**ROADWAY CONDITION EVALUATION**

**CALN TOWNSHIP  
CHESTER COUNTY, PENNSYLVANIA**

**File No. 23-07086**

**January 4, 2024**

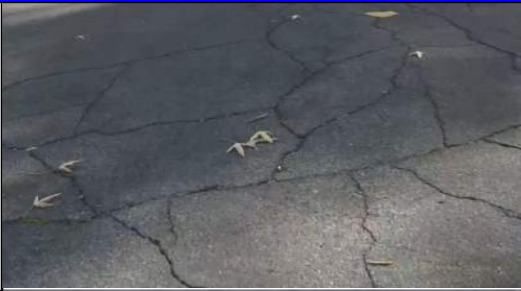
<b>DISTRESS</b>	<b>DESCRIPTION</b>	
Block Cracking	Interconnected cracking into rectangular or block-like pieces that can range in size from 1 to 100 square feet; generally caused from a poor binder choice in the mix design or aging in the asphalt binder

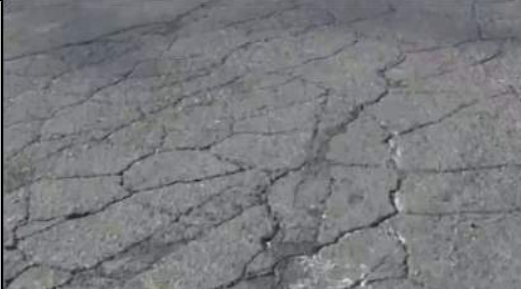
Fatigue/Alligator Cracking	Series of interconnected cracks that appear to resemble the back of an alligator that are caused by tensile stresses

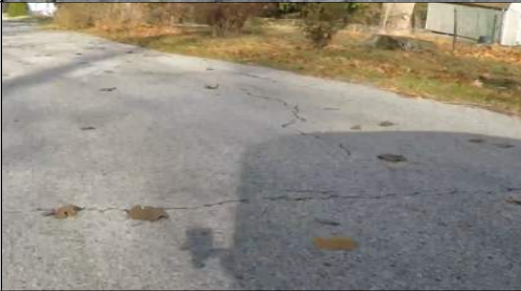
Longitudinal & Transverse Cracking	Cracking that occurs parallel (Longitudinal) and perpendicular (Transverse) to the centerline of the pavement that is caused by poorly constructed joints, thermal contraction and expansion, shrinkage in pavement layers, underlying cracking, wearing course fatigue

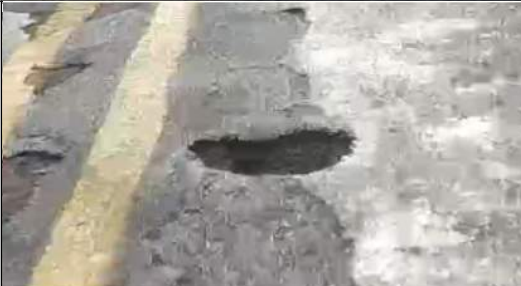
Potholes	Deep divots, pockmarks, and or holes in the pavement that are caused from snow and rain seeping into the cracks of the pavement, then freezing and thawing, creating voids in the pavement layers, and the weight of heavy vehicles causes cracked pieces to fall into the voids

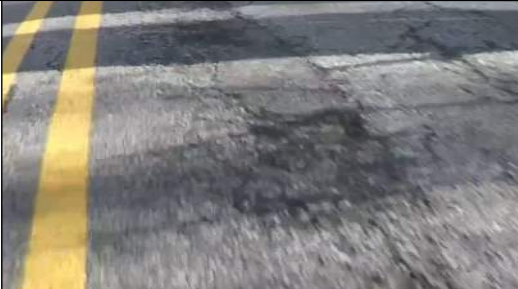
DISTRESS	DESCRIPTION	
Raveling	Disintegration of the asphalt binder and aggregate particles at the pavement surface caused from dust coatings bonding to the binder rather than the aggregate, poorly-graded aggregate particles, inadequate compaction during construction

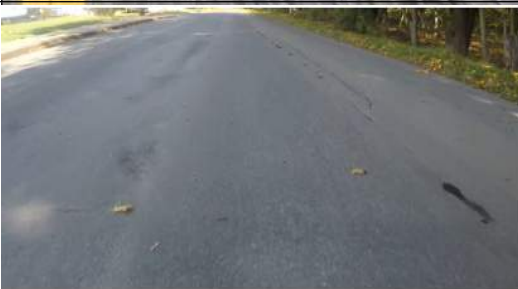
Rutting	Depressions, permanent deformation, and or consolidation in the pavement surface spanning parallel with the road, typically shown by the wheel path engraved on the road

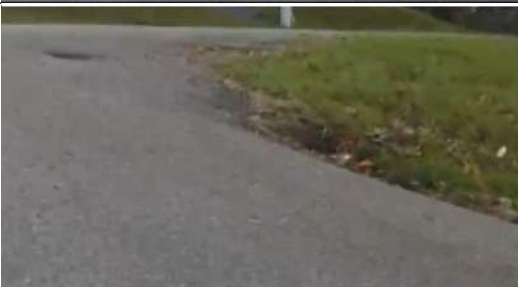
Shoulder Drop-Off	Drop in elevation between travel lanes, paved shoulders, and unpaved shoulders; caused from resurfacing roadways without raising the height of the shoulder or the abutting ground

During our field assessment, G&A observed many roads with unsupported edges. Although not considered a distress, in many cases the unsupported edges can lead to shoulder drop-off distresses. Shoulder drop-off distresses are commonly found in areas where the top of pavement grade is a few inches higher than the abutting subgrade, at corners of intersections where drivers make the turns short, in areas that have space for vehicles to pull off the roadway, and areas in neighborhoods where vehicles park off the side of the road. We recommend that – in conjunction with each road restoration project – shoulder drop-off areas be filled and compacted up to grade to prevent potential or minimize vehicle and roadway damage. The Township can prevent future shoulder drop-offs from occurring by installing guardrails, curbs, and or placing large boulders or rocks in these areas to make them undrivable.

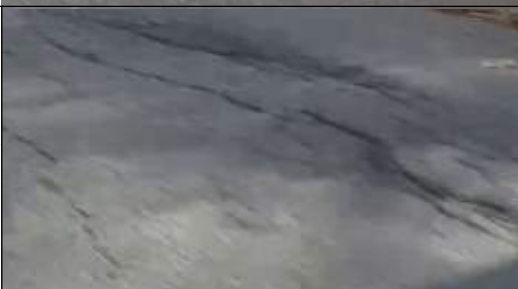
Shoving	Plastic movement creating a wave-like pattern across the surface, usually occurs at areas where asphalt abuts a rigid object; possible causes include mix contamination, poor mix design, lack of aeration of liquid asphalt emulsions, weak subgrades, or improper rolling during construction

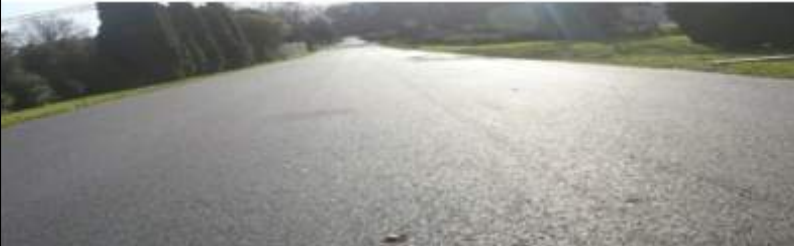
RATING	DESCRIPTION OF ROADWAY CONDITION	EXAMPLE
10	Roadway is in near perfect condition and has recently been re-paved.	<p>Fifteenth Avenue (North of Reed Street)</p>

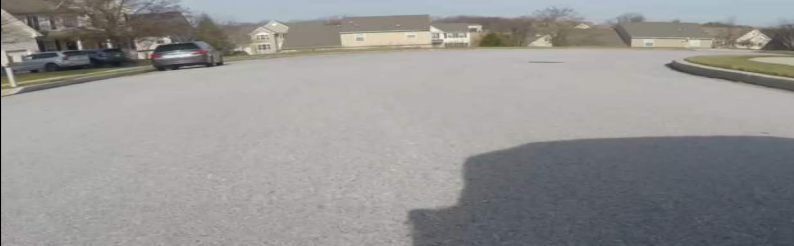
9	Roadway is in very good overall condition with some minor wearing/cracking observed.	<p>Albermarle Court</p>

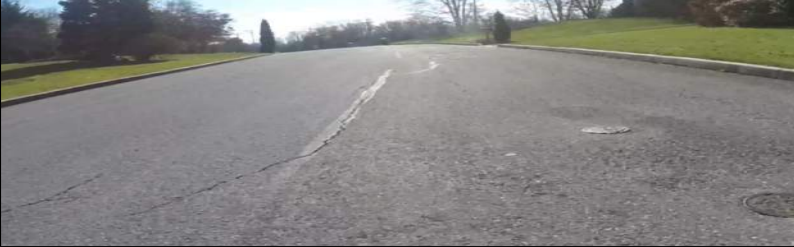
7-8	Roadway is in good condition but showed signs of wearing, oxidation, and more cracking.	<p>Elmwood Lane</p>

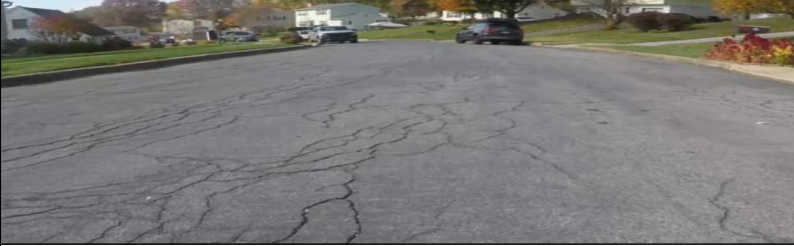
5-6	Roadway is in poor to fair condition and showed significant wear, oxidization, and widespread cracking.	<p>Grand View Lane</p>

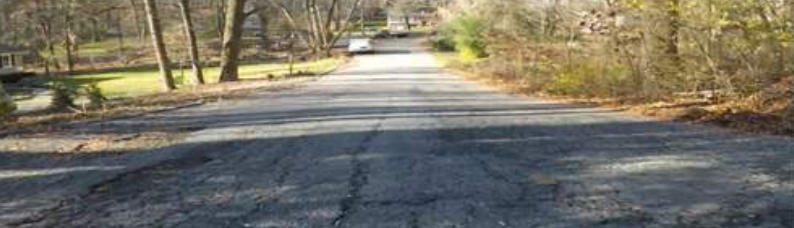
1-4	Roadway has failed.	<p>Ridge View Drive</p>

The five roads that received a score of 4 or less— Fifteenth Street (south of Reed Street), Longview Drive, Louanna Avenue, North Humpton Road, and Ridge View Drive – are considered to be at their failure point. We recommend these roadways be repaired as soon as possible to avoid further deterioration and to improve the use of the roadways by Township residents. These roads will require pavement reconstruction and therefore will be the most expensive to repair. North Humpton Road is in the worst condition with multiple severe potholes.

Based on the cost to obtain materials, schedule the work, mobilize the equipment and other construction costs, the Township may wish to consider performing the repairs to all five roads concurrently. The lengths of the five roads are relatively short (0.02, 0.51, 0.26, 0.11, and 0.25 miles, respectively); therefore, it may be feasible to perform the work under a single contract.

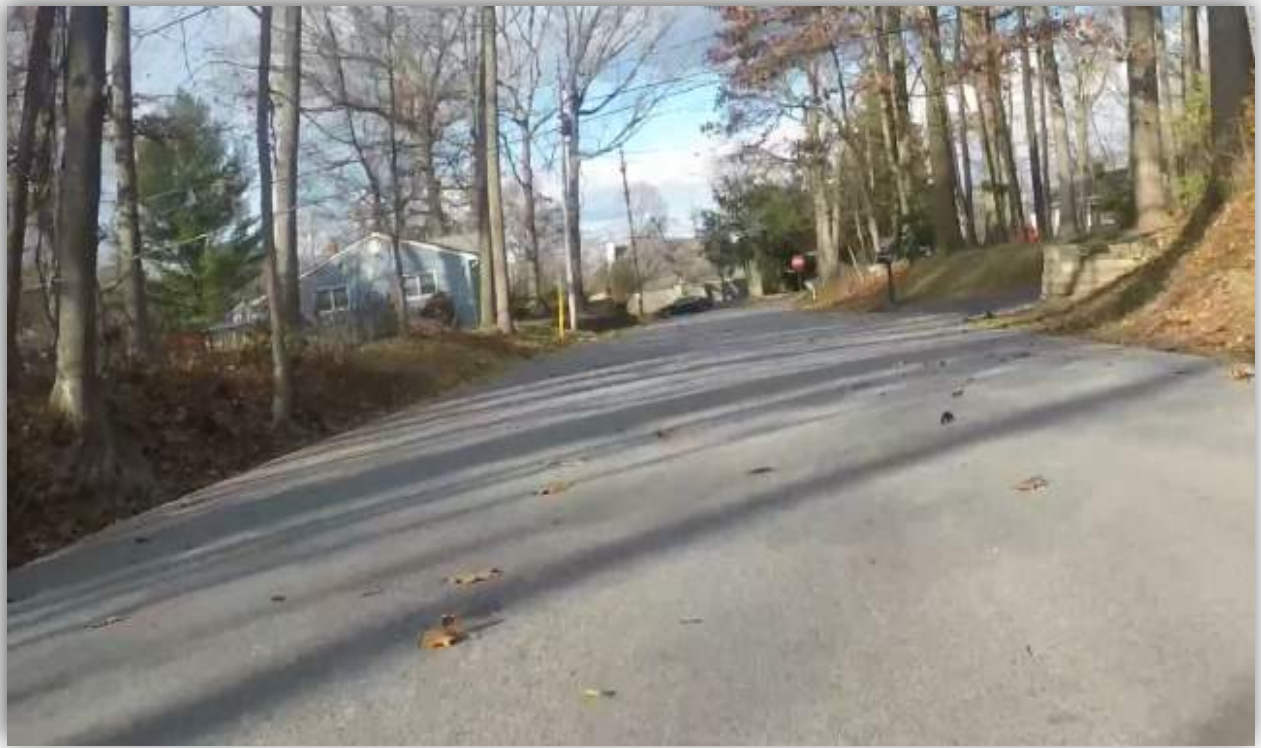
Acorn Street – Slight Weathering, 9 Score

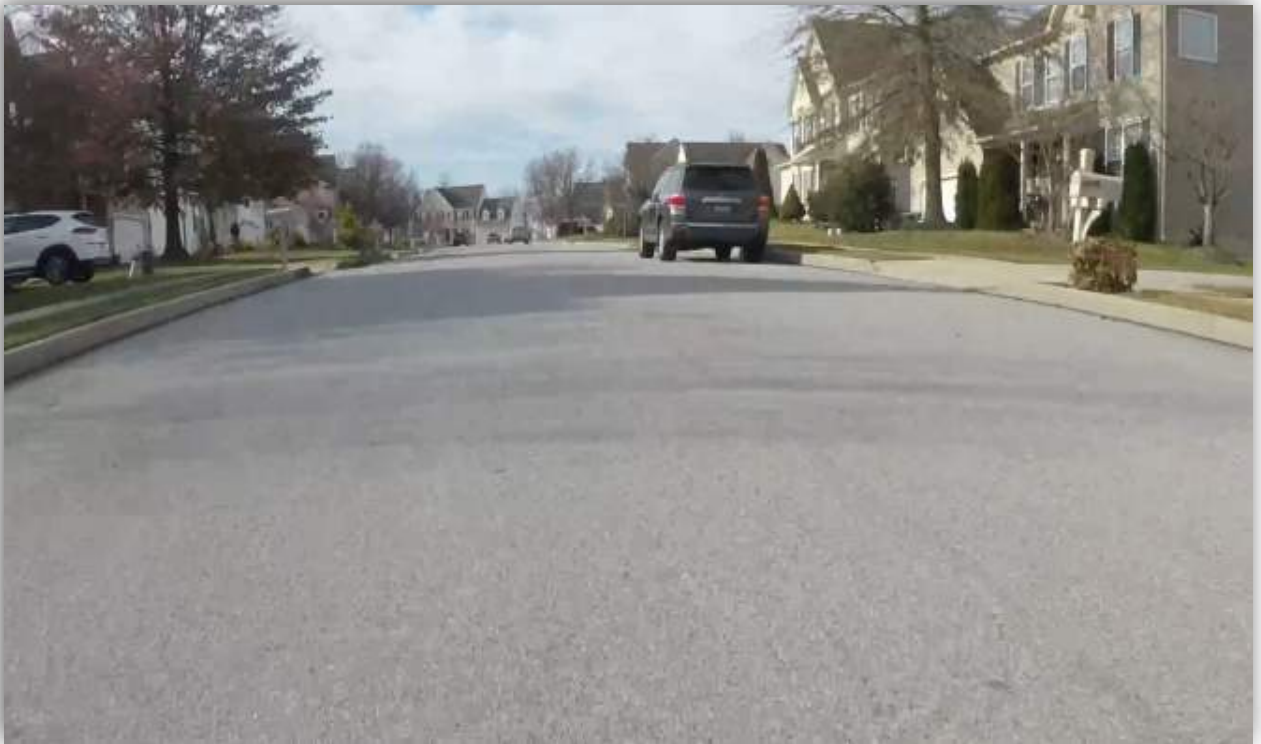
Balmoral Road – Slight Weathering, 9 Score

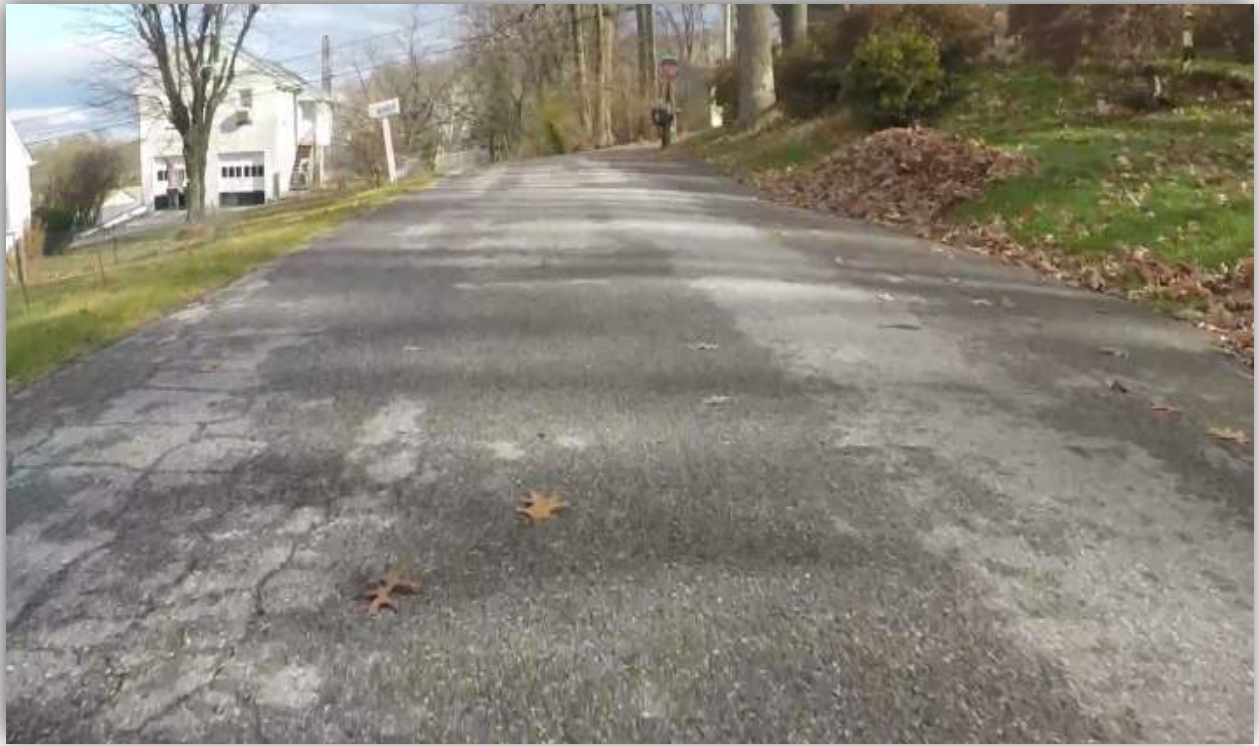
Bungalow Glade – Block Cracking, 6 Score

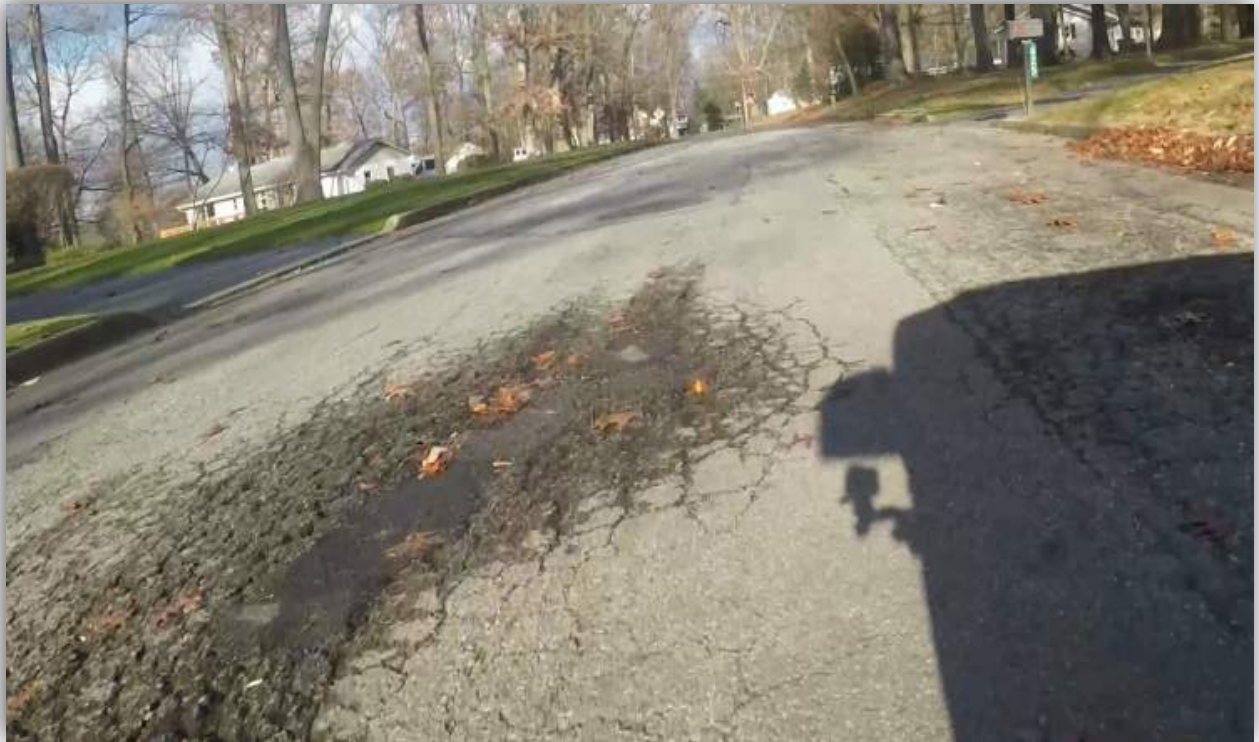
Roads receiving a score of 5 are in poor condition. The severity and spans of the distresses vary. Deer Drive is near failure as detrimental cracking was observed through the majority of the roadway span. Other roads, such as Dogwood Lane, showed localized severe distresses while other areas of the roadway were in good condition.

Dogwood Lane – Alligator Cracking, 5 Score

We recommend the Township evaluate roads with a rating of 5 individually to determine which roads should receive a full pavement reconstruction or a pavement fabric overlay/mill and overlay. To make this determination, field studies such as pavement cores may be necessary. In some instances, the Township may elect to perform mill and overlays on sections of roadways. Careful consideration should be made as these roadways are near failure and delaying repair work could be the difference between a pavement overlay repair versus full pavement reconstruction.

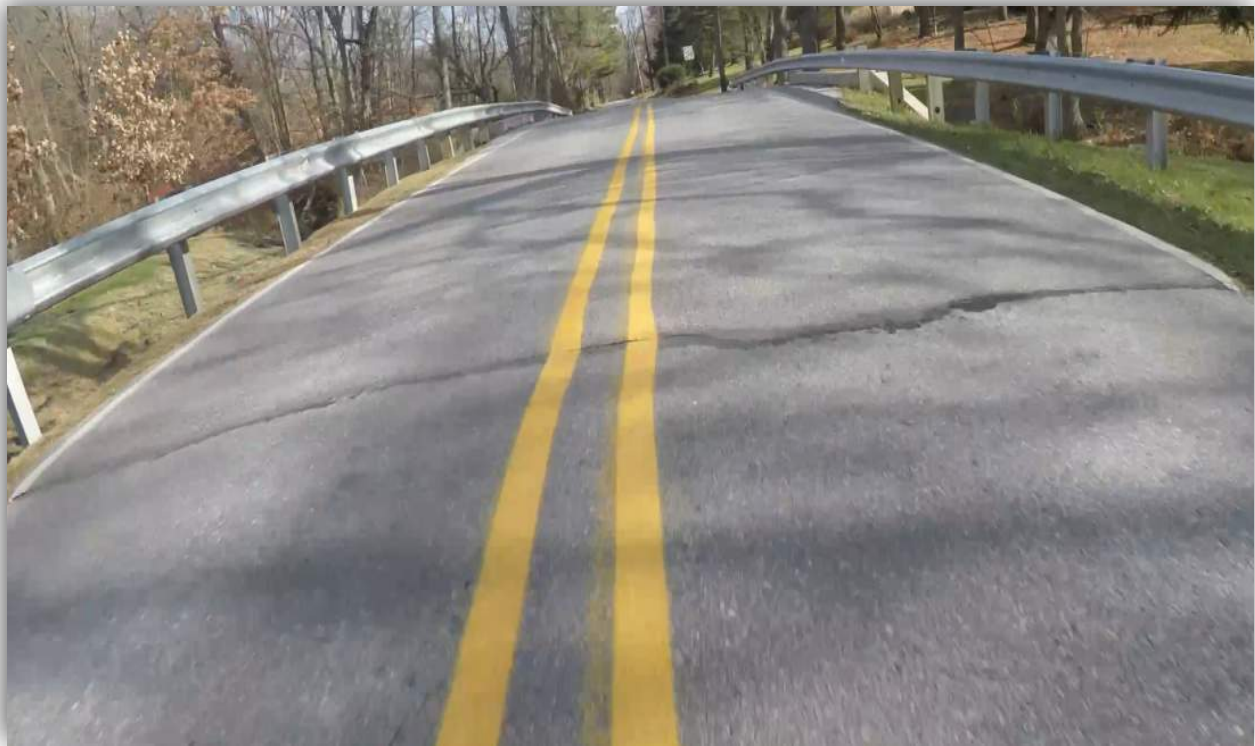
Fisherville Road – Transverse Crack, 6 Score

Roads receiving a rating of 6 are considered to be in fair condition and generally immediate repairs are not required to prevent roadway failure. To prevent further degradation of the fair rated road locations, the Township may want consider placing surface treatment in the next maintenance cycle. For localized distress areas, placement of cold patch, crack sealant, and sectional patching may also be viable options to prevent localized distresses from growing into larger repair efforts. We recommend that roadways with higher traffic volumes and longer extents, such as Barley Sheaf Road and Fisherville Road, be prioritized for surface treatment.

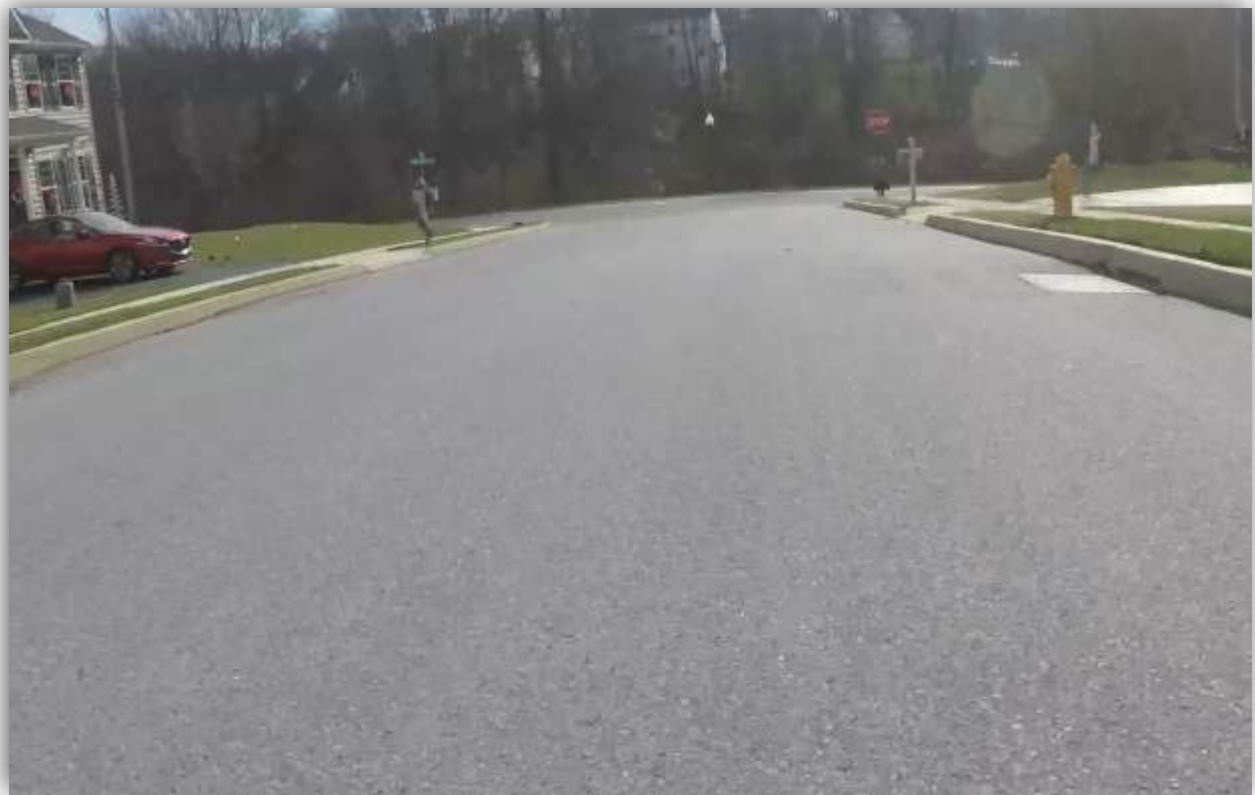
Fitzwilliam Court – Slight Weathering, 9 Score

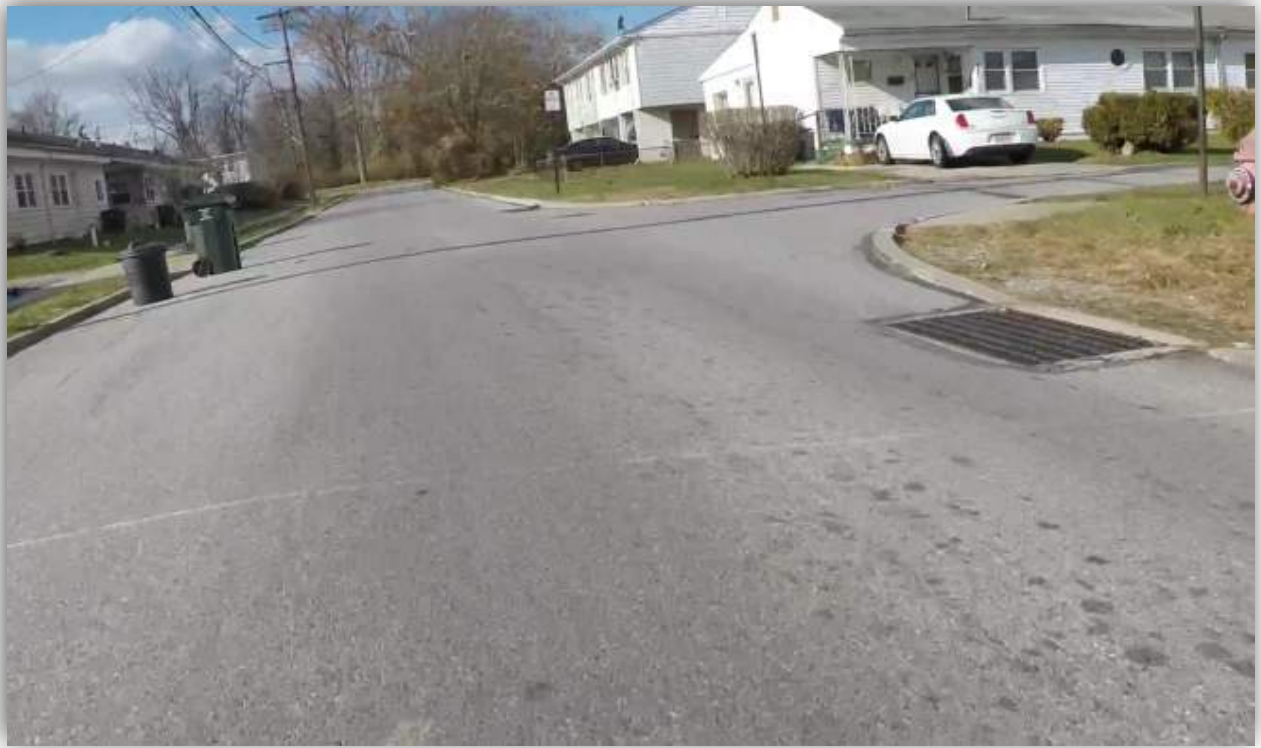
Fox Avenue – Depression around Inlet, 7 Score

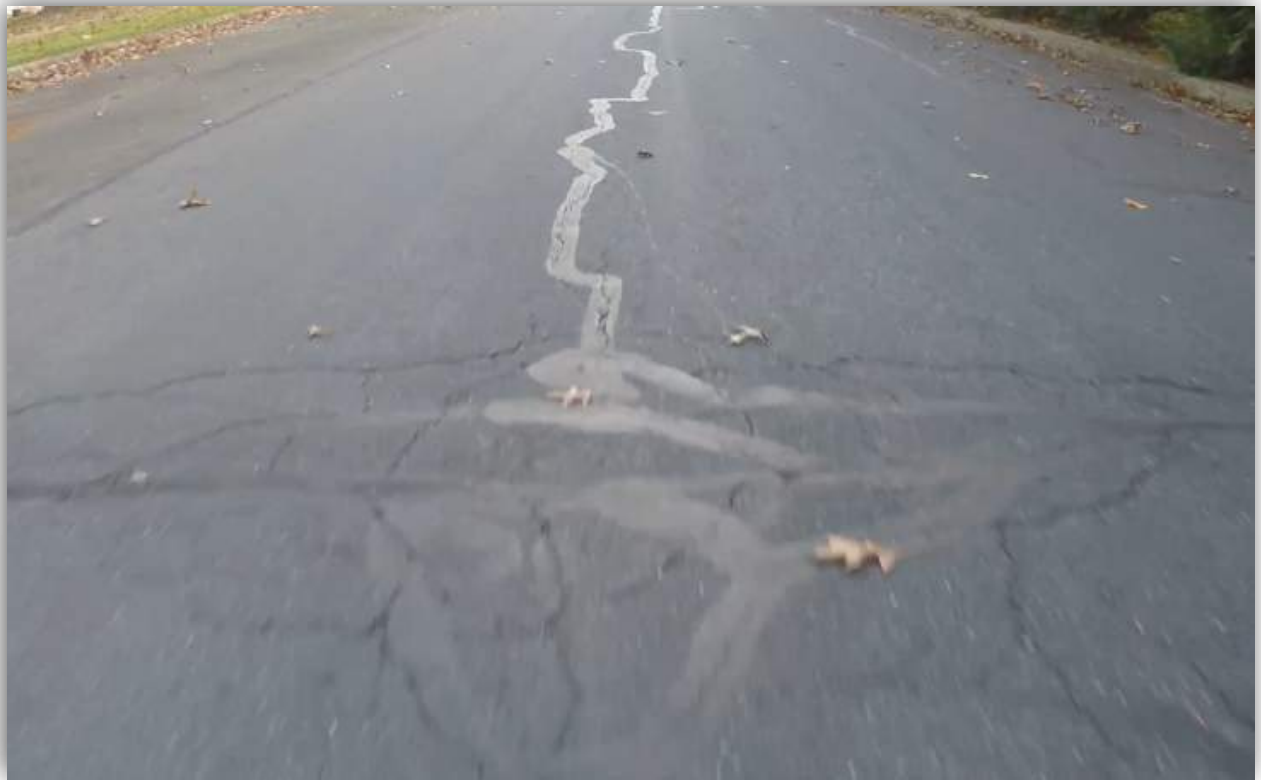
Glen Ridge Drive – L&T Cracking, 7 Score

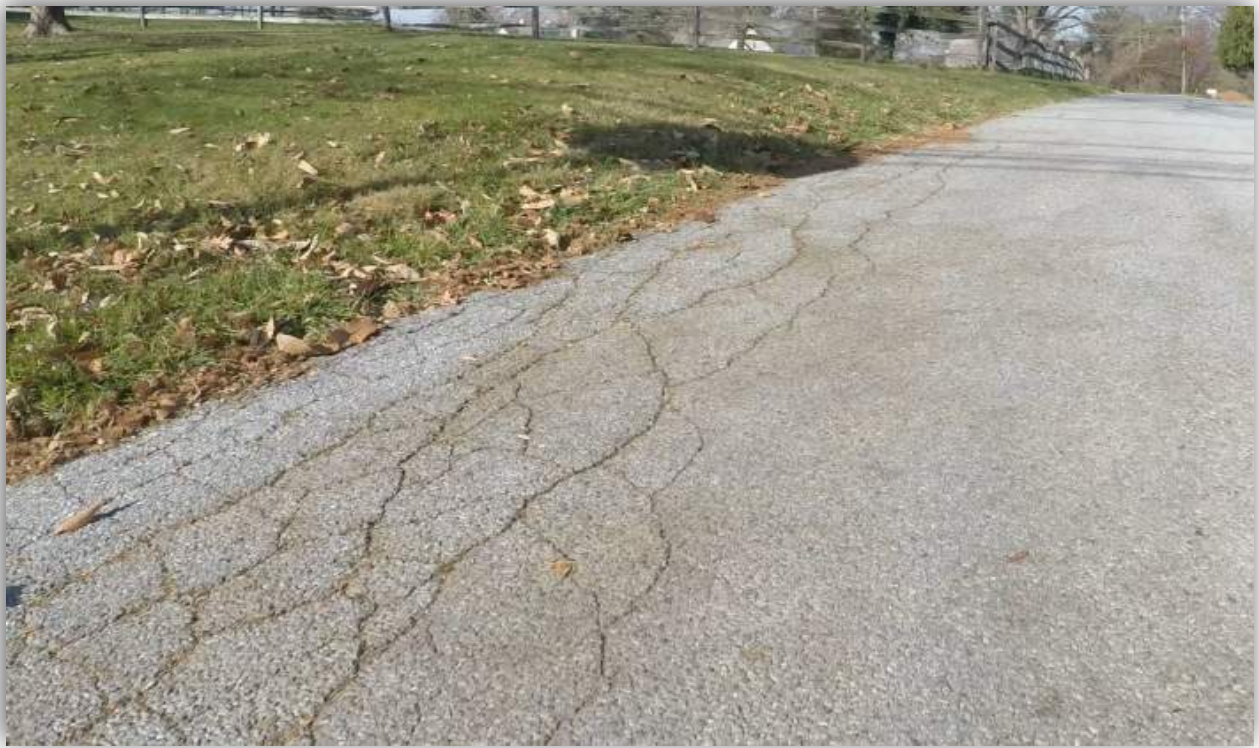
Grandview Road – Edge Cracking, 7 Score

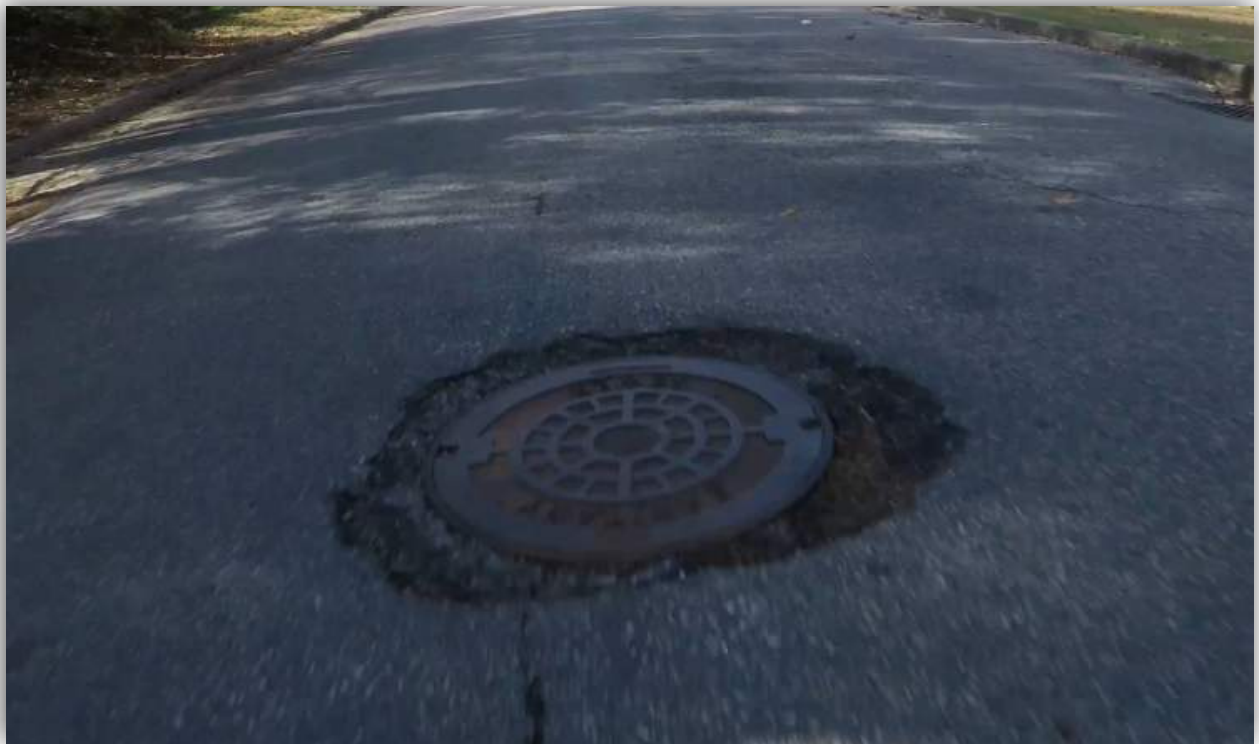
Greenwood Circle – Pothole around Manhole, 7 Score

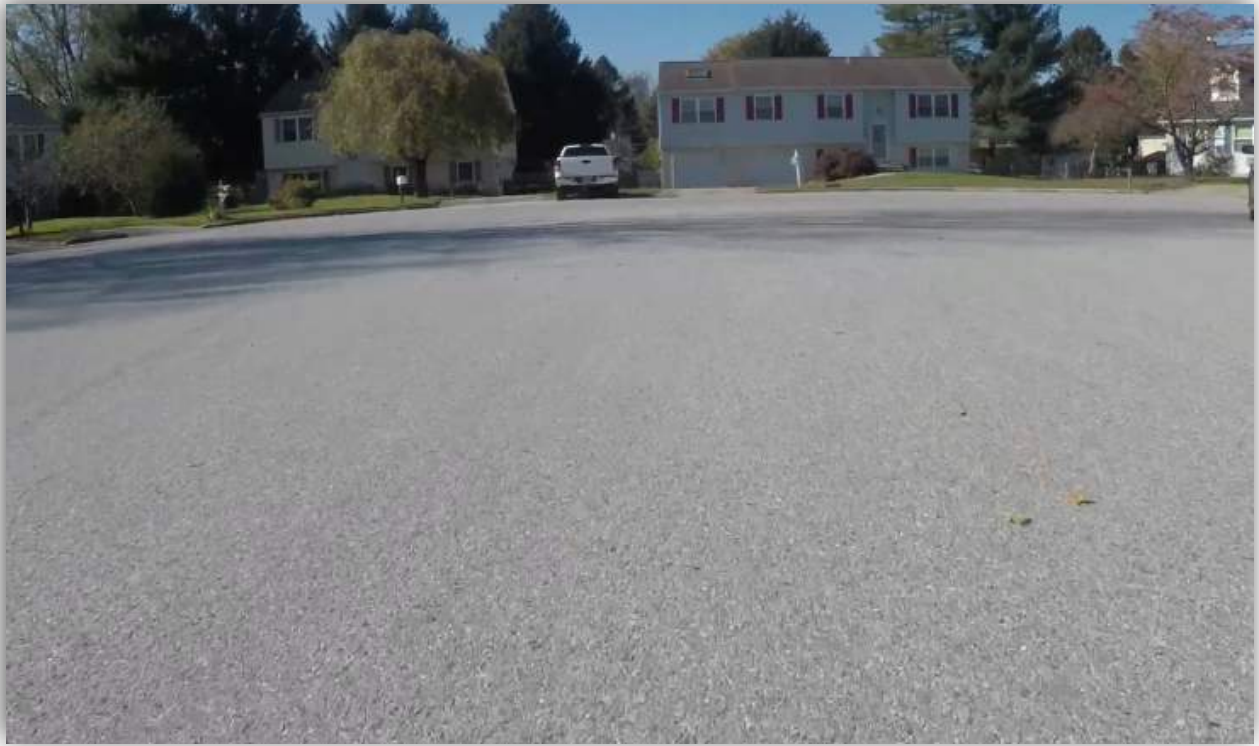
Heather Court – Slight Weathering, 9 Score

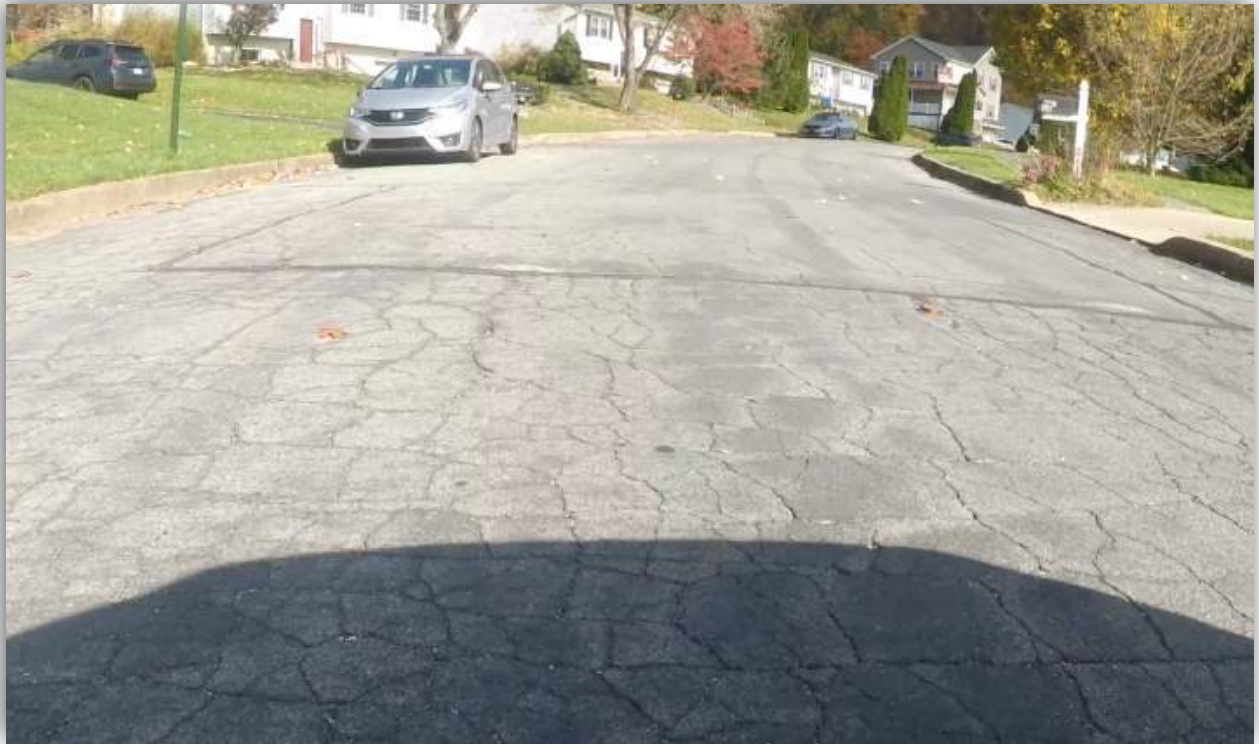
Hillcrest Drive – Block Cracking, 6 Score

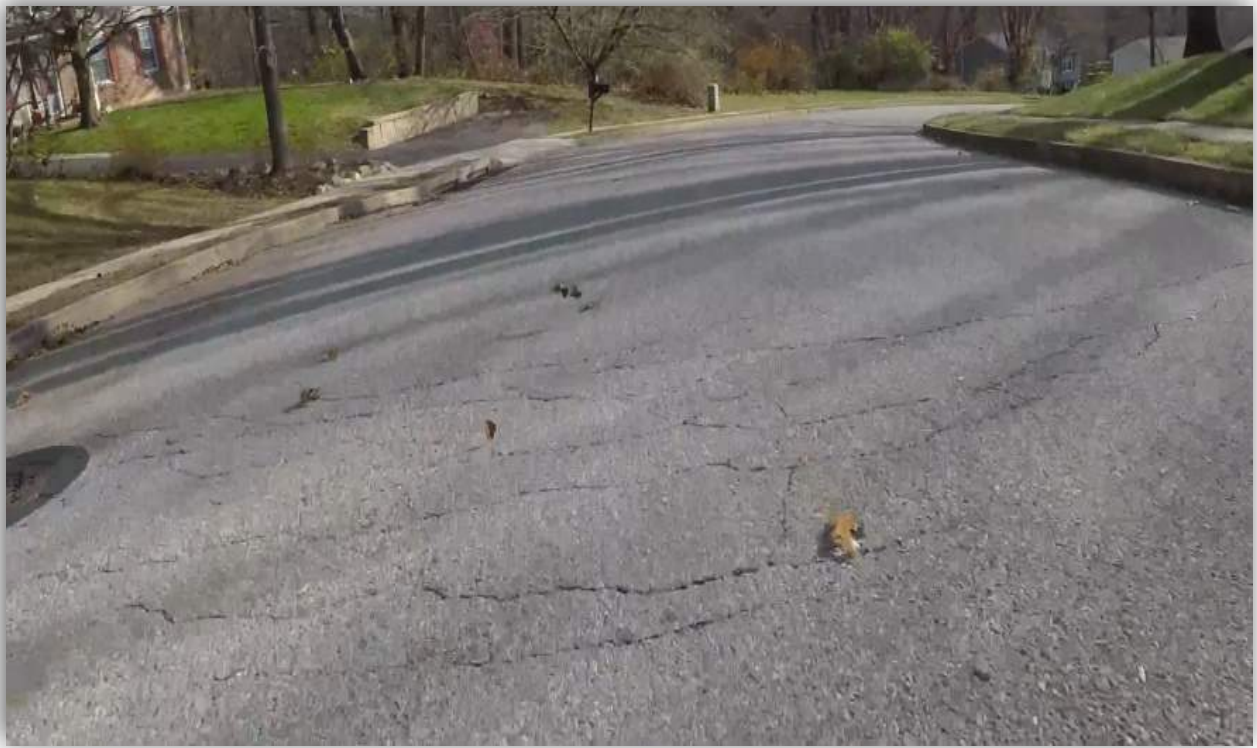
Jennifer Drive – Transverse Cracking, 7 Score

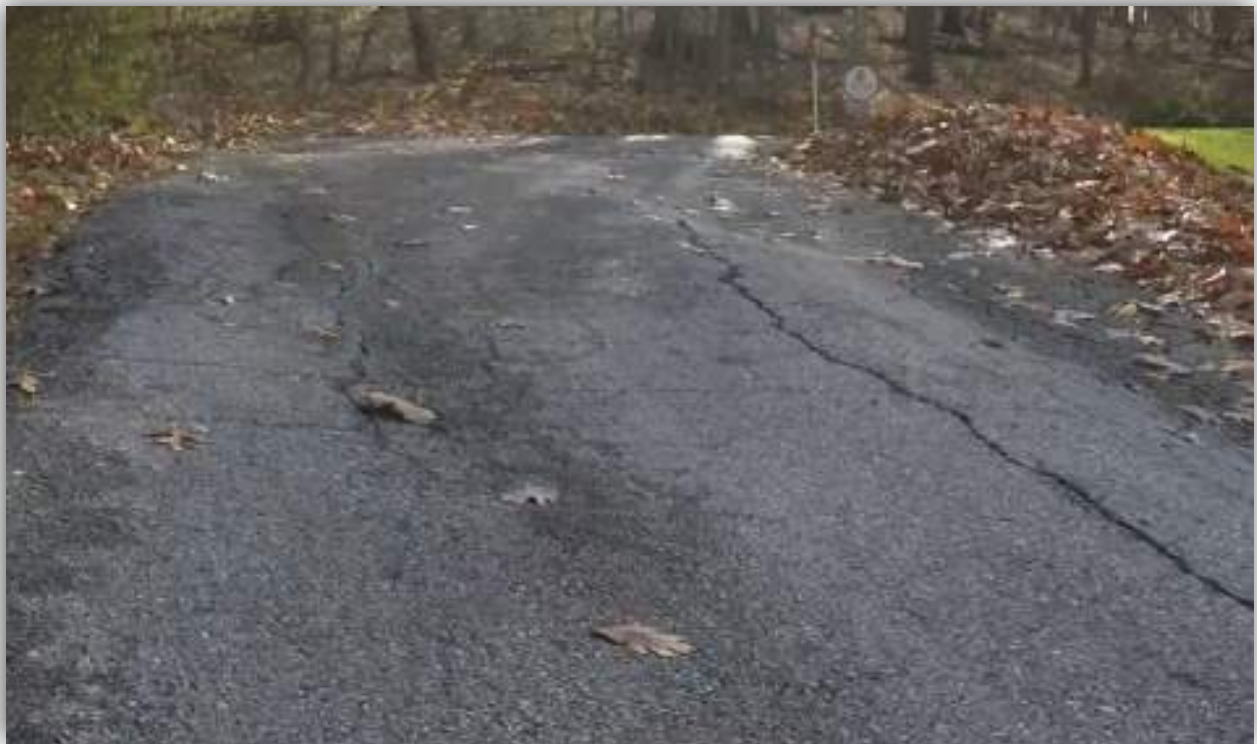
Jewell Avenue – Rutting and Cracking at South End, 7 Score

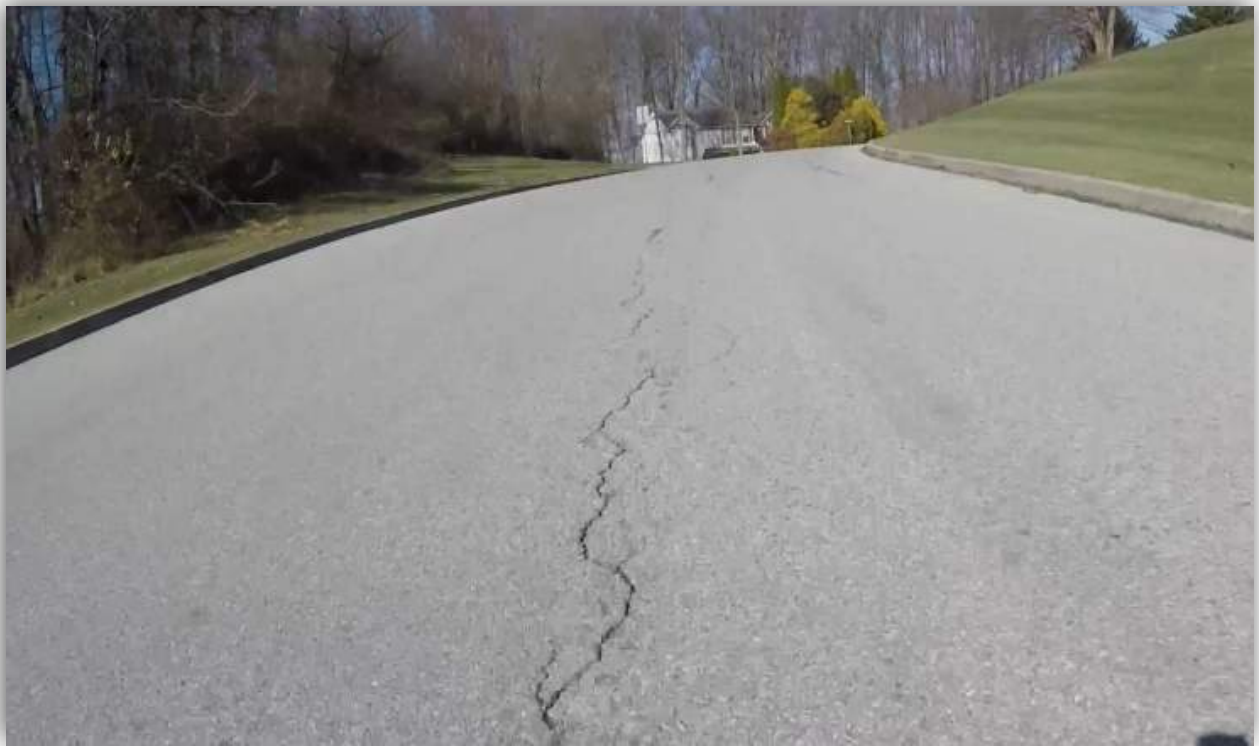
Kingswood Lane – Longitudinal Cracking, 8 Score

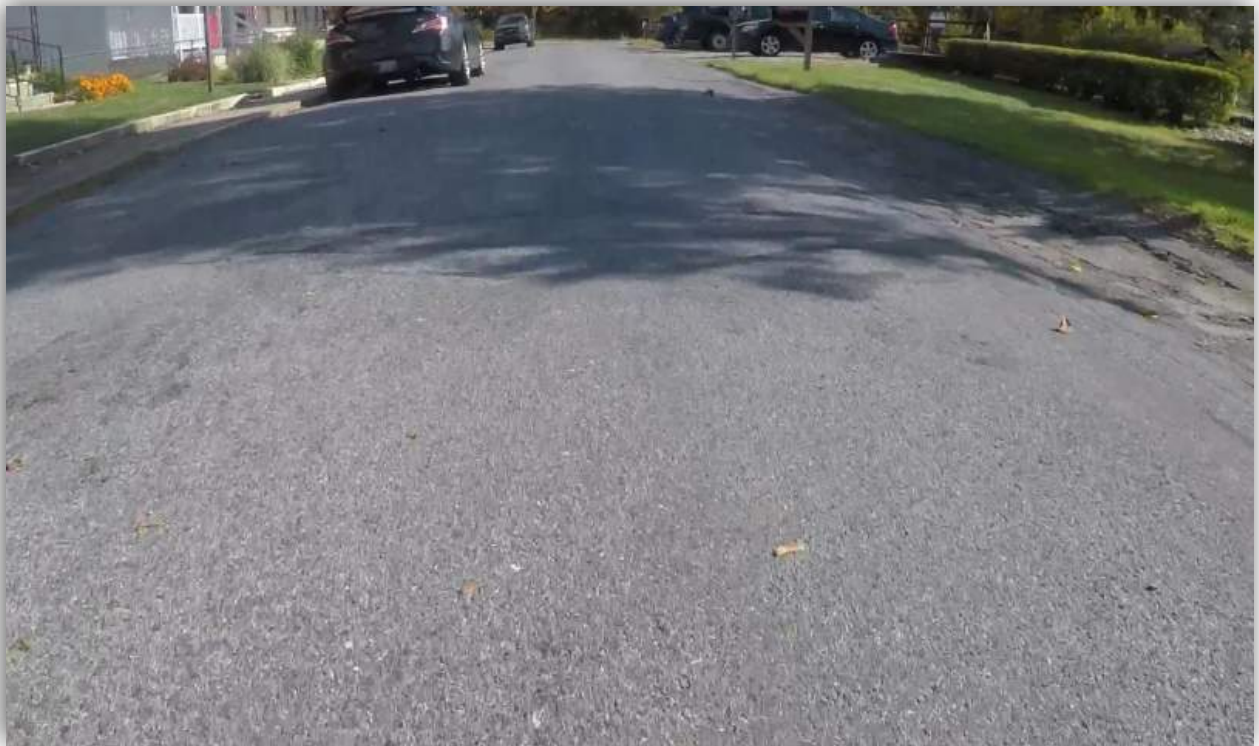
Maple Avenue – Depression & Raveling, 6 Score

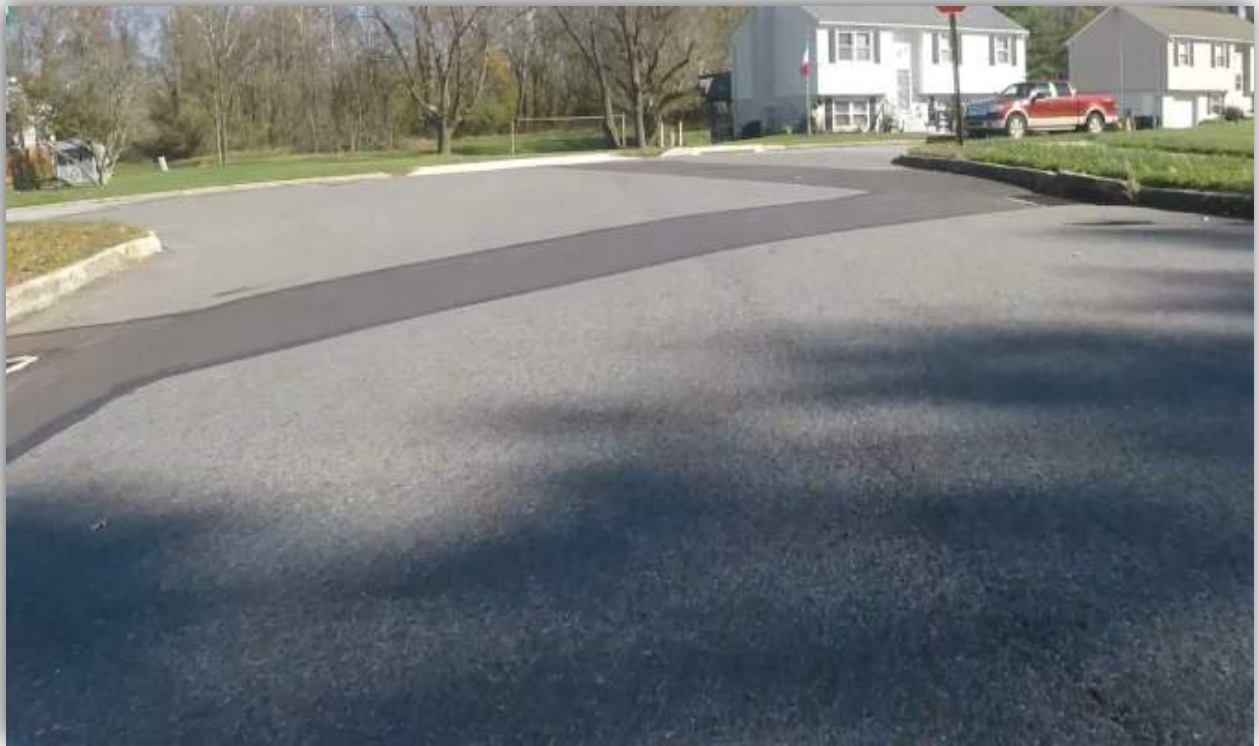
Meadow Drive – Slight Weathering, 8 Score

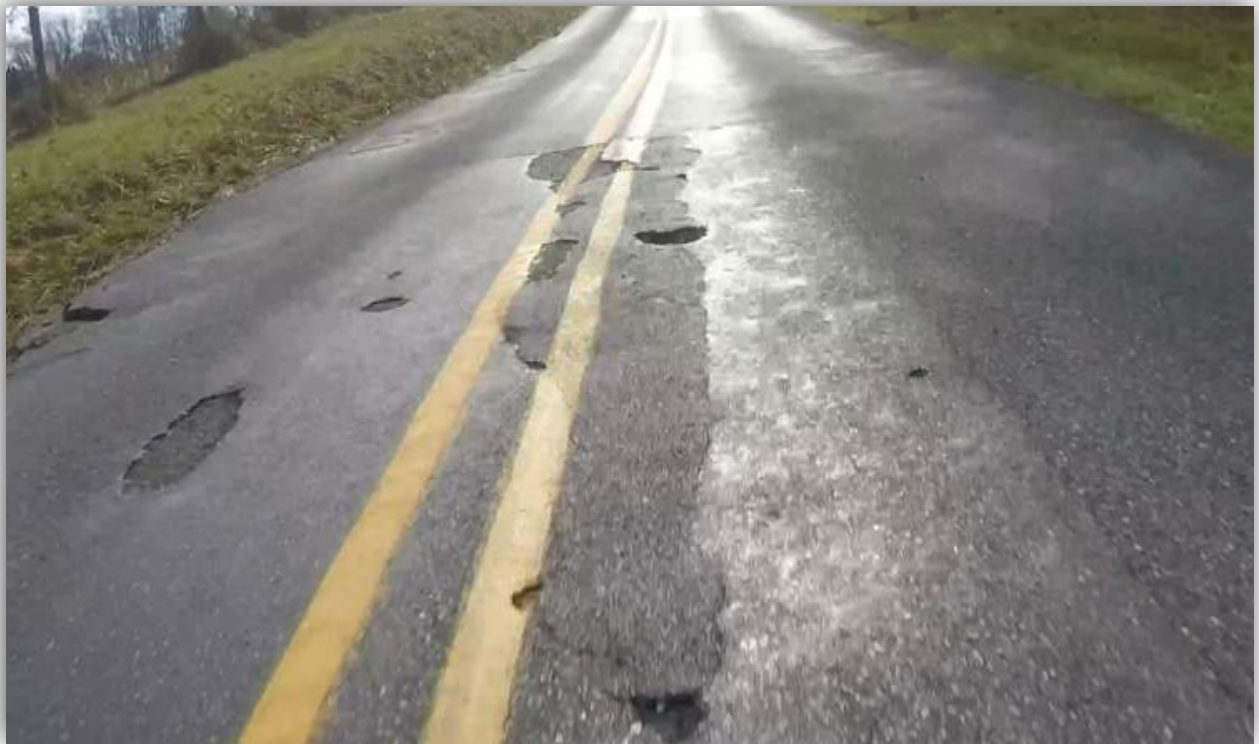
North Bailey Road (North) – Potholes & Raveling, 6 Score

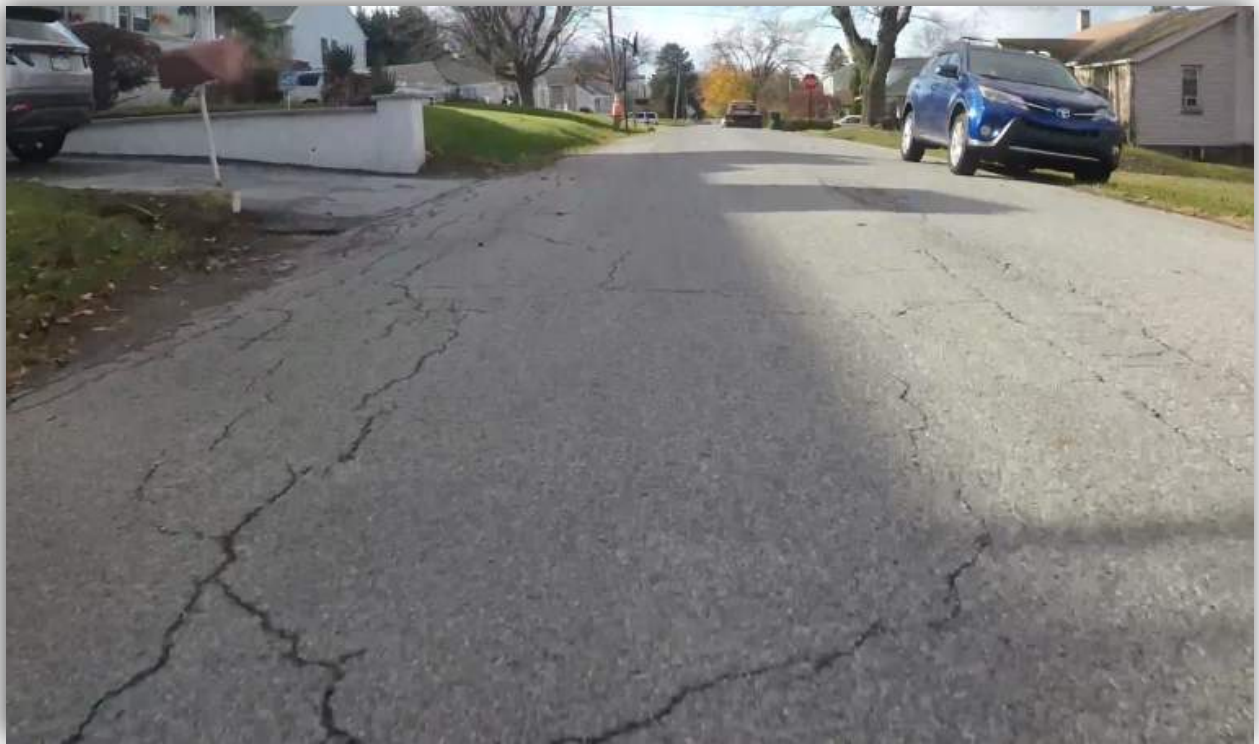
Norwood Avenue – Cracking, 6 Score

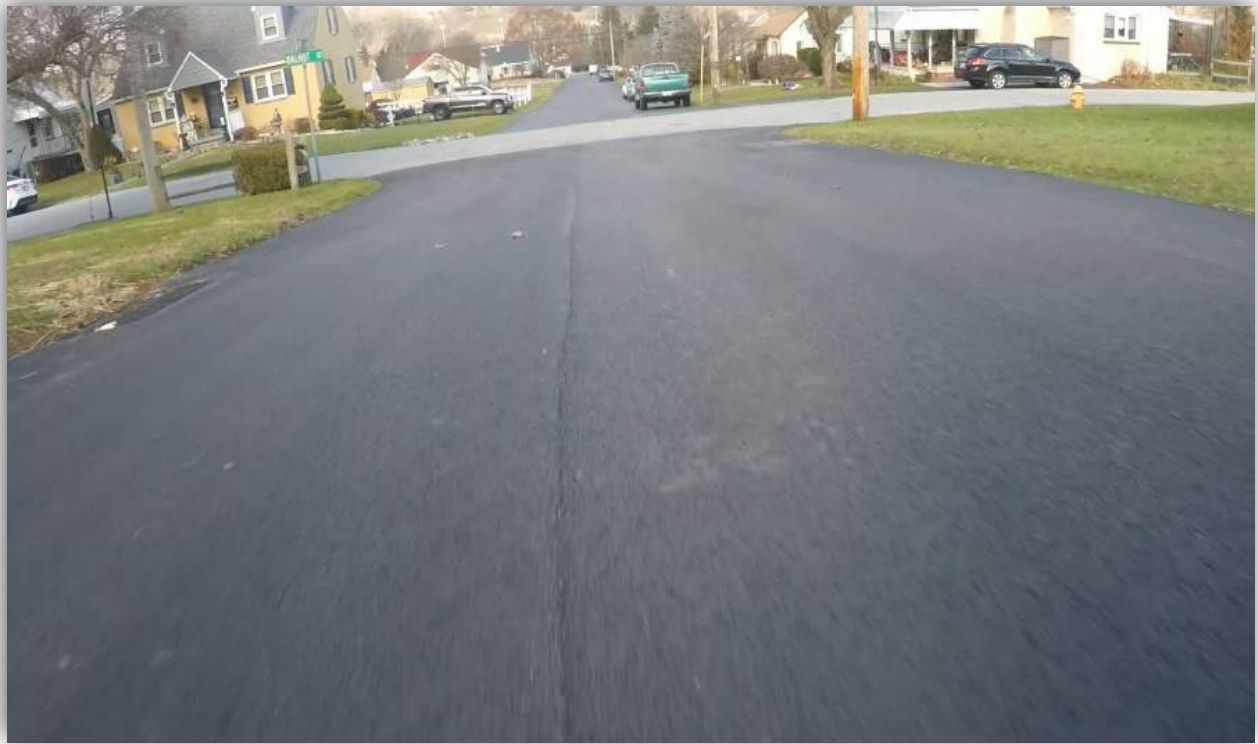
Sixteenth Street – Crack down the Centerline, 9 Score
