**ROADWAY CONDITION EVALUATION**

**CALN TOWNSHIP  
CHESTER COUNTY, PENNSYLVANIA**

**File No. 23-07086**

**January 4, 2024**

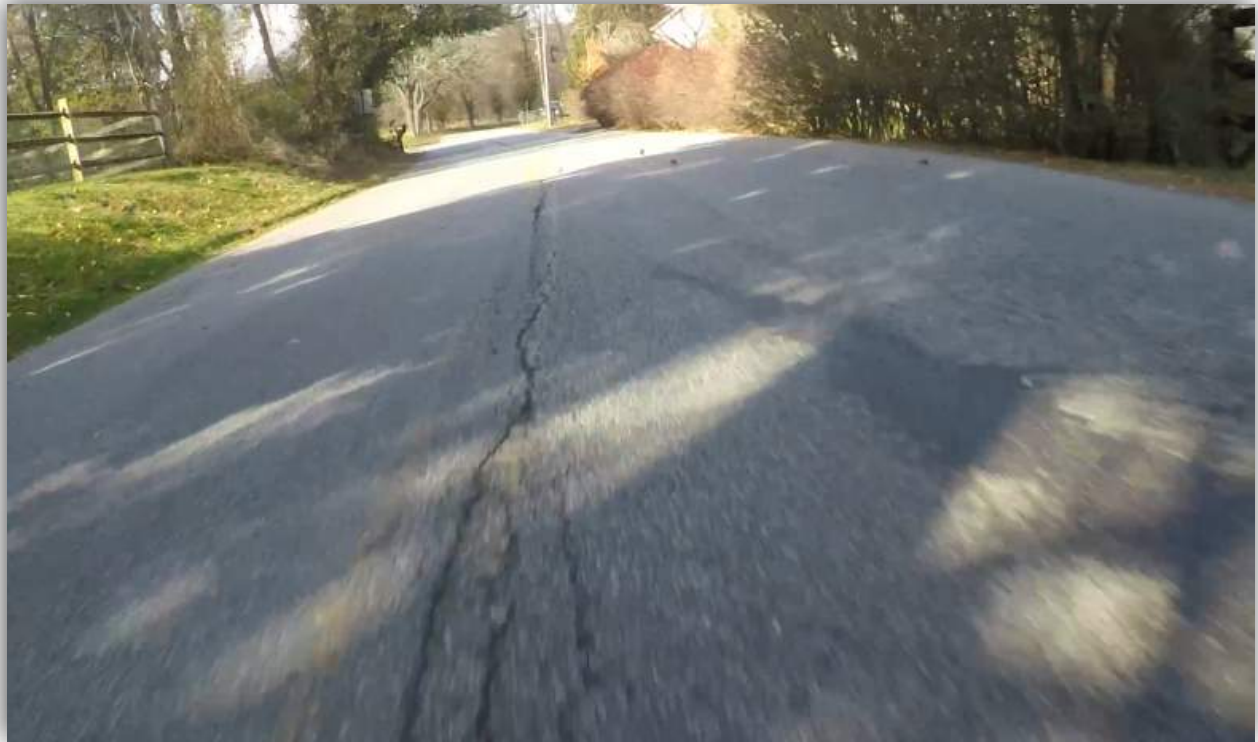
South Caln Road – Longitudinal Cracking along Centerline, 7 Score

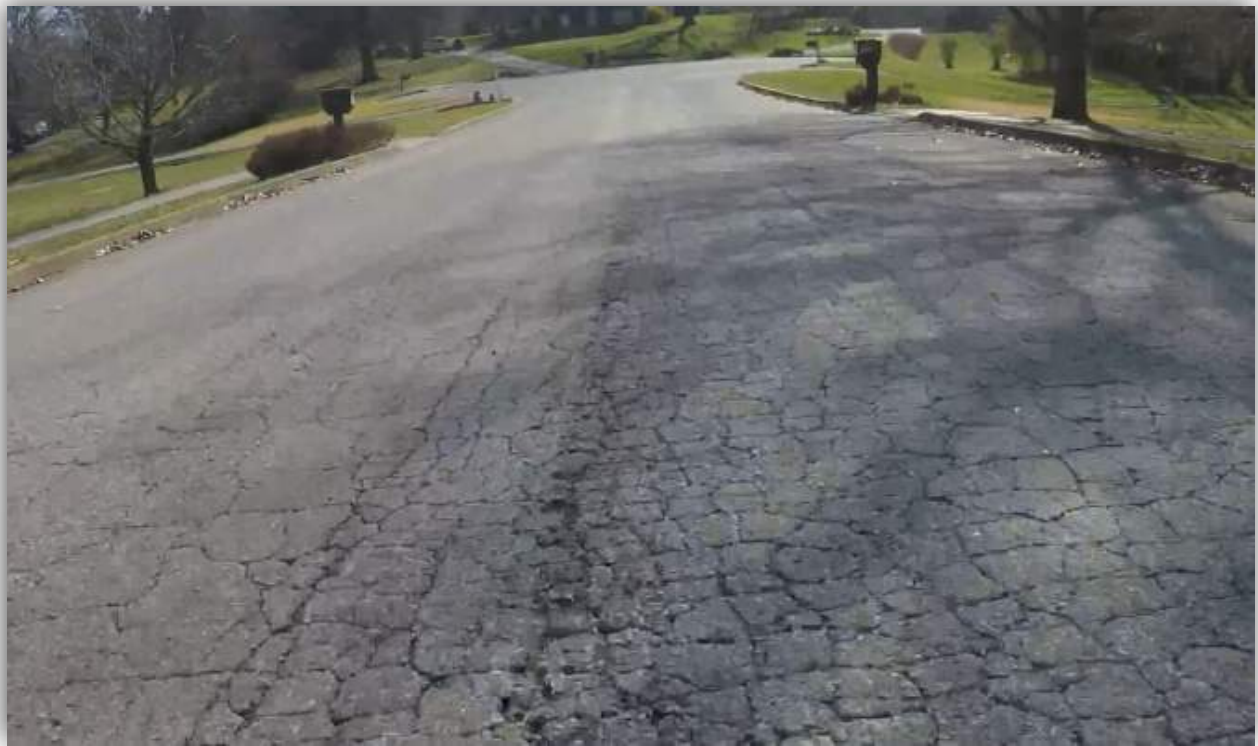
Schoolhouse Lane – Alligator Cracking in Small Area, 7 Score

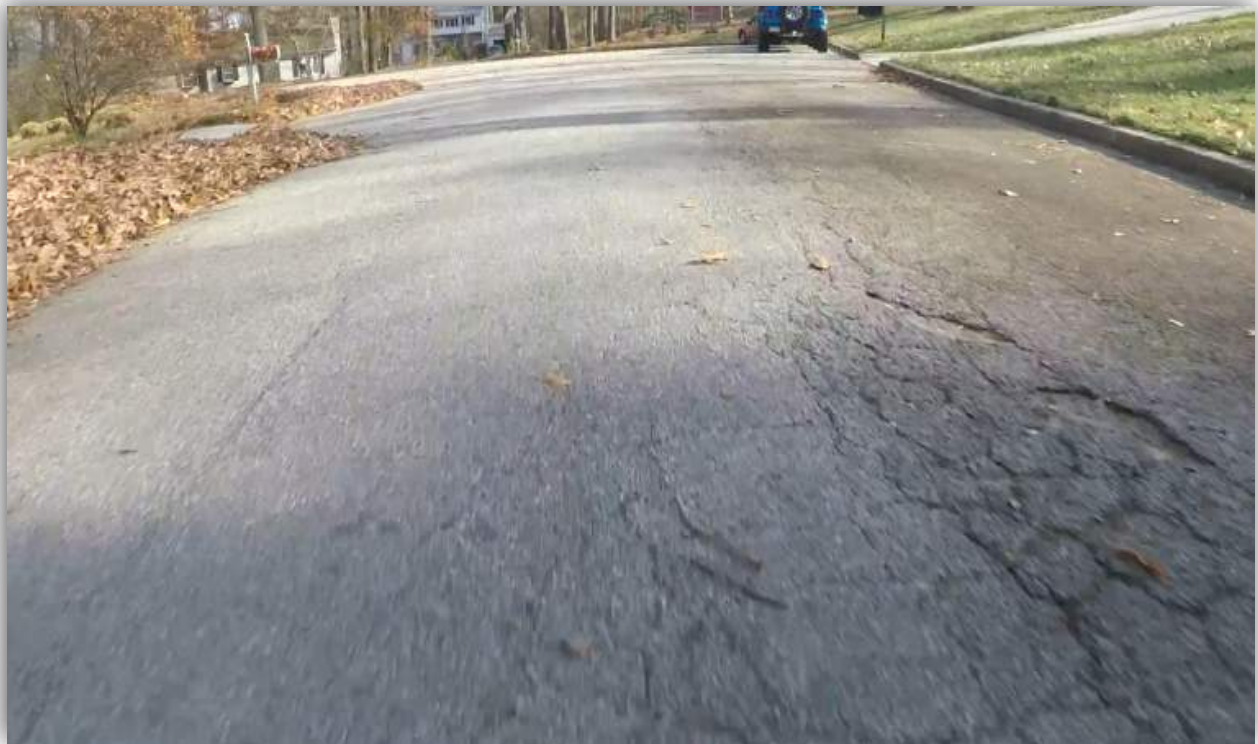
Woodview Drive – Alligator Cracking & Raveling, 7 Score
