Caln Township Capital Improvements Plan

MAY 2019

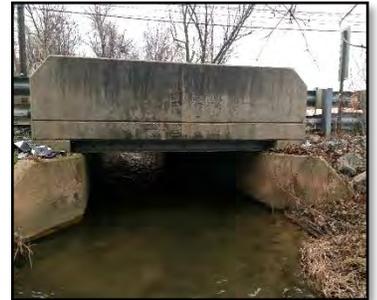
abutments, steel beams, and a concrete deck that was widened with concrete and steel beams in order to accommodate two lanes of traffic and a pedestrian sidewalk. The original stone masonry abutments and steel beams require significant repair. There is undermining, dislodged stones, and rusted beams observed with the structure. Recommendations include structural repairs and blasting and painting of the structural beams.

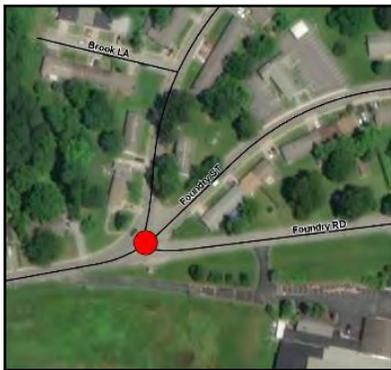
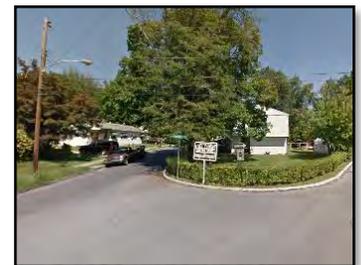
This project is located at the entrance of Carver Court on Foundry Street. Currently, there is a one-way sign at the entrance to the community however the flow direction of traffic is not clear. Vehicles are parked on either side of the road, restricting the width of the travel lane. Recommendations include further evaluation of the traffic patterns in this area and improvements to the signage and pavement markings.

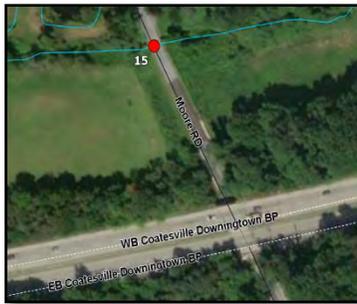
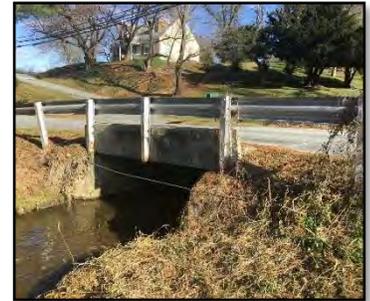
This project is located on Moore Road, 0.15 miles south of the Kings Highway intersection at the stream crossing. The bridge is an original stone masonry and timber structure that was widened to accommodate a second lane of traffic. The wooden beams are not in contact with the existing concrete deck of the structure. It is recommended that the bridge be evaluated by a structural engineer in order to determine if the structure should have a weight limit posted. Additionally, it is recommended that the structural abutments be repaired.

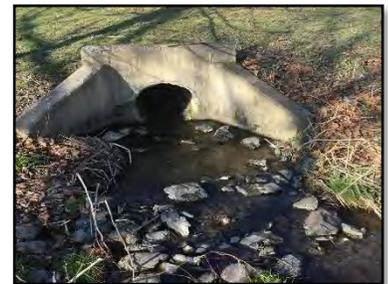
This project is located on G.O. Carlson Boulevard, east of the Municipal Drive intersection at the stream crossing. The pipe is a 24-inch corrugated metal pipe conveying an Unnamed Tributary to Valley Run. The pipe shows significant signs of corrosion, with significant scale rust along the bottom third of the pipe. It is recommended that the pipe be lined in order to increase the structural integrity of the pipe and protect the remaining metal from further corrosion.

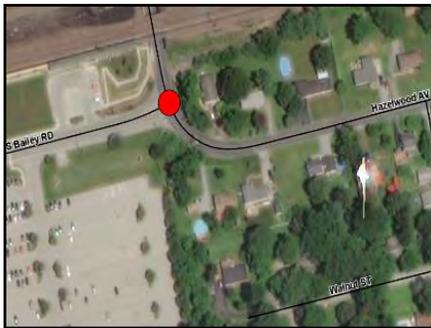
This project is located at the intersection of South Bailey Road and Hazelwood Avenue before the train underpass. Currently, there is a stop sign at the intersection for traffic coming west from South Bailey Road while the two other directions have the right-of-way. The approach of Hazelwood Avenue to the intersection is a very sharp continuous curve, making it difficult for all traffic to safely exchange at the intersection. Recommendations include evaluation of the traffic patterns in this area to improve the safety of this intersection.

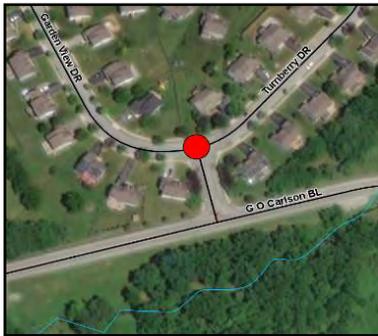
This project is located at the intersection of Links Way, Garden View Drive and Turnberry Drive within The Links at Thorndale Greene community.

Currently, there is a stop sign at the intersection for traffic coming from G.O. Carlson Boulevard while the two other directions have the right-of-way. During high volume traffic times throughout the day, traffic from G.O. Carlson Boulevard backs up at the stop sign into the busy G.O. Carlson Boulevard. This poses a safety hazard for those stopped cars entering The Links at Thorndale Greene community. Recommendations include evaluating the traffic patterns for the intersection to correct this issue.

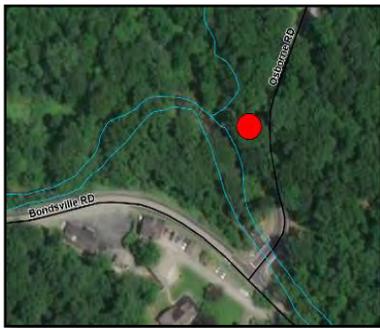
This project is located on Osborne Road north of the Bondsville Road intersection. On the western side of the Osborne Road, a stormwater pipe discharges beyond the edge of the roadway. There is significant erosion around this discharge site that compromise the stability of the roadside. It is recommended that repairs be made to correct the erosion and minimize the potential for erosion in the future.

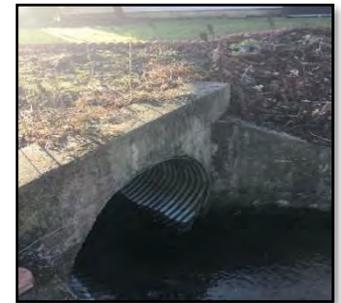
This project is located on Barclay Street, within the Barley Sheaf Farms community, at the stream crossing upstream of the pond. The pipe is a corrugated metal arch pipe culvert that is approximately 50-inches in height by 60-inches in width conveying an Unnamed Tributary under Barclay Street. The pipe has scaling rust and debris inside. The pipe also appears to be installed incorrectly, with the first joint connection visible from the upstream end of the pipe. In addition to the pipe deficiencies, there is significant streambank erosion occurring on the upstream end. This area is highly prone to flooding. It is recommended that the pipe be lined in order to prevent further deterioration or future problems with the pipe. Additionally, to address the effects from the drainage, approximately 285 linear feet of stream restoration and realignment to the stream is recommended to address to the flooding issues.

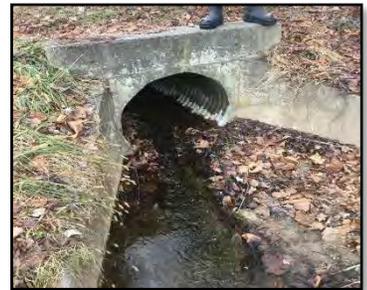
This project is located on Lynn Boulevard, south of the Humpton Road intersection at the stream crossing. The pipe is a 36-inch corrugated metal pipe conveying an Unnamed Tributary to Beaver Creek. The pipe is showing significant signs of scale rust formation along the bottom of the pipe, which is present along the entire bottom of the pipe. Additionally, the upstream conditions indicate that the pipe may be inadequately sized. It is recommended that the size of the pipe be evaluated and lined to extend the life of the pipe.

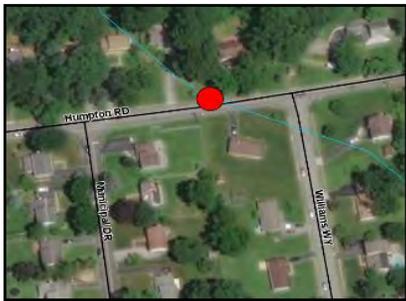
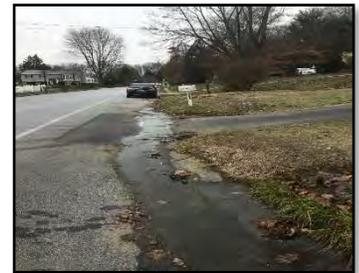
This project is located on Humpton Road between the Municipal Drive and Williams Way intersections on the northern side of the road. There is a rock/grass conveyance on private property that runs into the Township storm sewer system. The system conveys an ephemeral stream. During storm events, there is significant flooding, which has brought degradation to the stormwater system along Humpton Road and the private yards it runs through. It is recommended to restructure the system to withstand the flow from the ephemeral stream into the Township storm sewer system. These improvements would also help to reduce the icing potential along this portion of Humpton Road in the winter.
