# Caln Township Capital Improvements Plan

JUNE 27, 2019

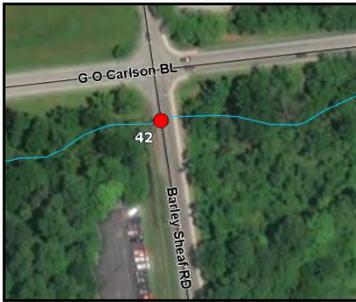
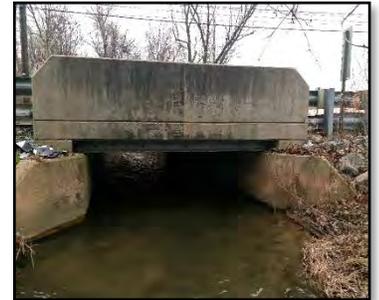
abutments, steel beams, and a concrete deck that was widened with concrete and steel beams in order to accommodate two lanes of traffic and a pedestrian sidewalk. The original stone masonry abutments and steel beams require significant repair. There is undermining, dislodged stones, and rusted beams observed with the structure. Recommendations include structural repairs and blasting and painting of the structural beams.

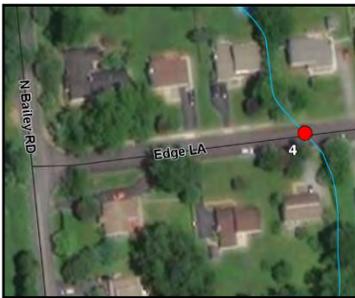
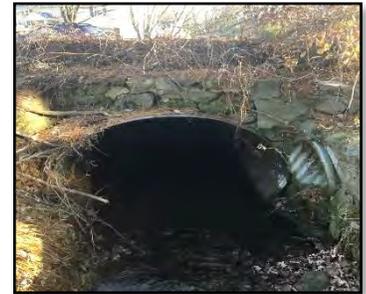
This project is located on Edge Lane, east of the N. Bailey Road intersection at the stream crossing. The pipe is an elliptical corrugated metal arch pipe approximately 36 inches in height by 70 inches in width, conveying an Unnamed Tributary to Valley Run. The structure shows significant scaling rust just above the waterline along the bottom of the entire length of the pipe. The pipe is misaligned and, at times, contains standing water. It is recommended that the pipe be completely replaced.

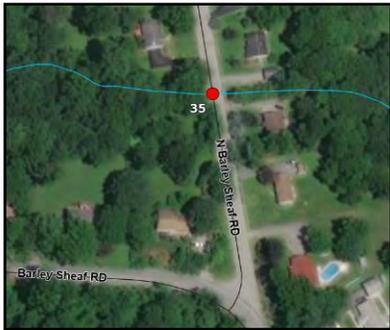
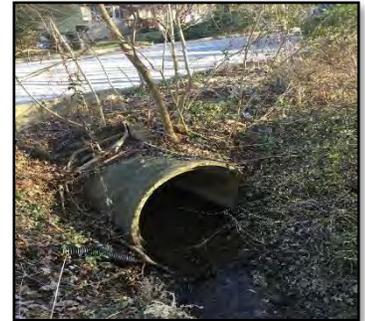
movement in the slope, inlet and curb above the pipe. Additionally, the inlet tops are set directly on top of the existing pipe, draining through holes cut in the top of the pipe sections. Cracking and depressions in the pavement surface above the pipe were observed and are likely cause primarily by inadequate backfill compaction at the time of installation. There is also significant scouring on the upstream end of the pipe, likely due to a combination of the pipe disconnection and the flow of water in the area during high water events. It is recommended that the pipe be reconnected to the stream sections and stabilize the bank. Further repair should be considered as well, which includes replacement of inlets and pavement repairs.

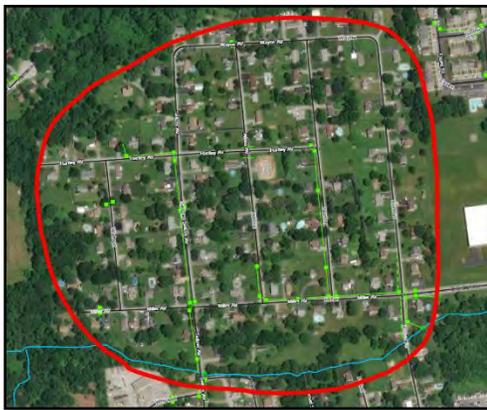
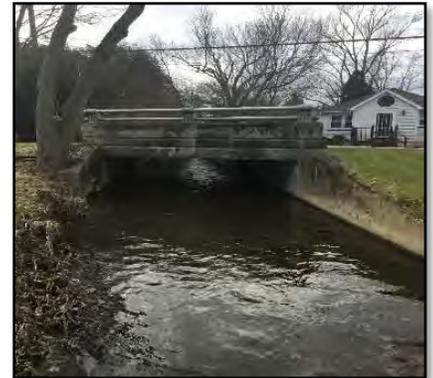
This project is located within the drainage area of the following avenues: Loomis, Wayne, Hartley, Norton, Atkins, Seltzer, Watson, Miller. This area experiences flooding, specifically where Valley Run flows through a bridge under Loomis Avenue. The aging stormwater infrastructure in this area may also contribute to the flooding. The stormwater system poses a maintenance challenge as well, as the publicly owned infrastructure are closely intertwined with privately owned infrastructure.

It is recommended that a comprehensive stormwater management study be conducted for this area in order to determine the drainage patterns, including an analysis of the stream flow under the bridges in this area, in order to

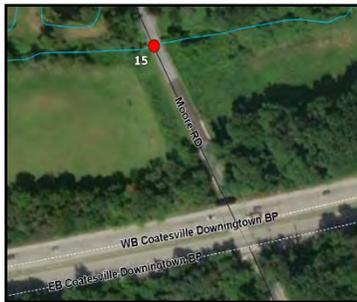
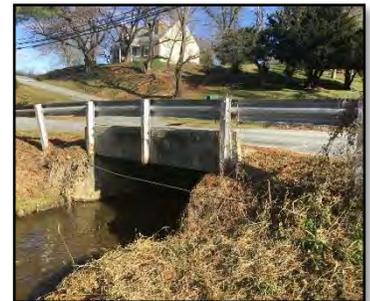
This project is located on Moore Road, 0.15 miles south of the Kings Highway intersection at the stream crossing. The bridge is an original stone masonry and timber structure that was widened to accommodate a second lane of traffic. The wooden beams are not in contact with the existing concrete deck of the structure. It is recommended that the bridge be evaluated by a structural engineer in order to determine if the structure should have a weight limit posted. Additionally, it is recommended that the structural abutments be repaired.

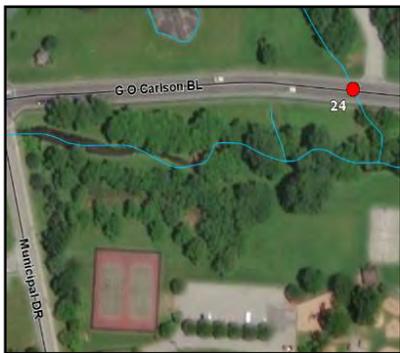
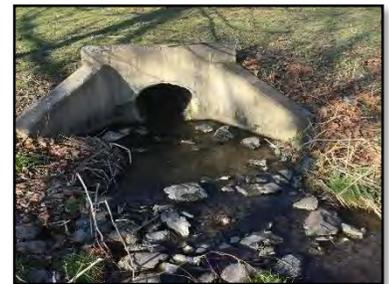
This project is located on G.O. Carlson Boulevard, east of the Municipal Drive intersection at the stream crossing. The pipe is a 24-inch corrugated metal pipe conveying an Unnamed Tributary to Valley Run. The pipe shows significant signs of corrosion, with significant scale rust along the bottom third of the pipe. It is recommended that the pipe be lined in order to increase the structural integrity of the pipe and protect the remaining metal from further corrosion.

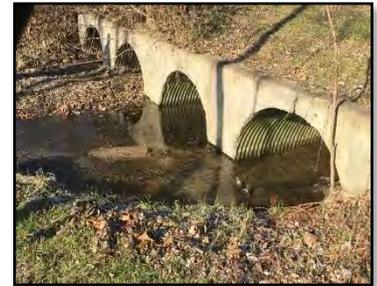
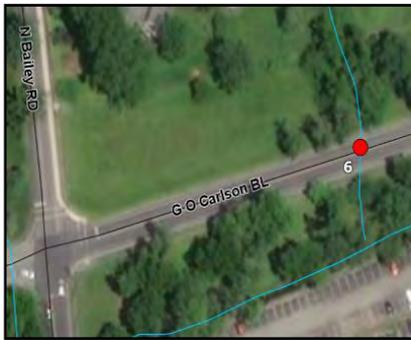
This project is located on G.O. Carlson Boulevard, east of the N. Bailey Road intersection at the stream crossing. The structure consists of 4 corrugated metal arches, each approximately 40 inches in height by 66 inches in width, conveying an Unnamed Tributary to Valley Run. There is a significant amount of sediment within the structure in addition to a dip observed in the center of all the pipes, due to settlement. Additionally, the curbing above the pipe shows noticeable signs of settlement. It is recommended that the entire structure is replaced.

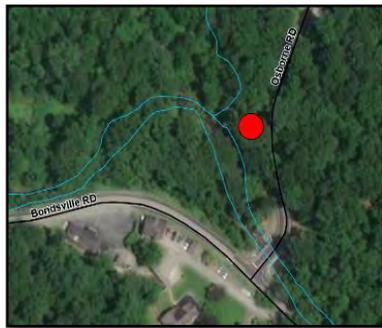
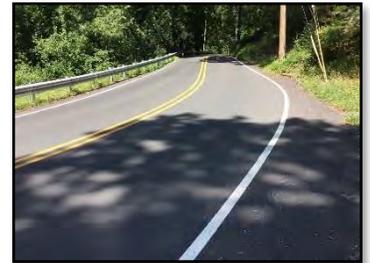
This project is located on Osborne Road north of the Bondsville Road intersection. On the western side of the Osborne Road, a stormwater pipe discharges beyond the edge of the roadway. There is significant erosion around this discharge site that compromise the stability of the roadside. It is recommended that repairs be made to correct the erosion and minimize the potential for erosion in the future.

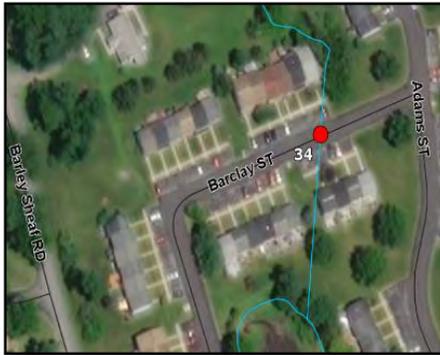
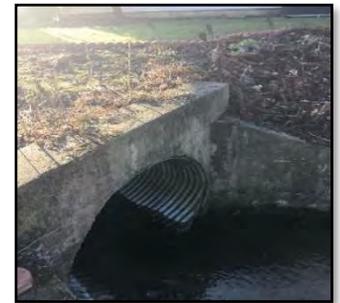
This project is located on Barclay Street, within the Barley Sheaf Farms community, at the stream crossing upstream of the pond. The pipe is a corrugated metal arch pipe culvert that is approximately 50-inches in height by 60-inches in width conveying an Unnamed Tributary under Barclay Street. The pipe has scaling rust and debris inside. The pipe also appears to be installed incorrectly, with the first joint connection visible from the upstream end of the pipe. In addition to the pipe deficiencies, there is significant streambank erosion occurring on the upstream end. This area is highly prone to flooding. It is recommended that the pipe be lined in order to prevent further deterioration or future problems with the pipe. Additionally, to address the effects from the drainage, approximately 285 linear feet of stream restoration and realignment to the stream is recommended to address to the flooding issues.

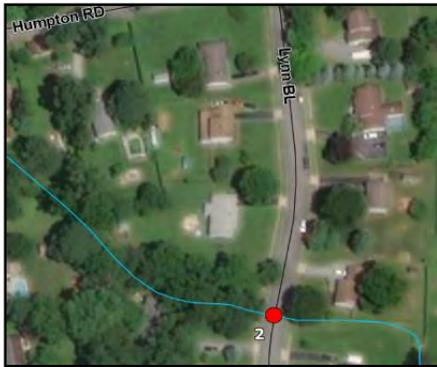
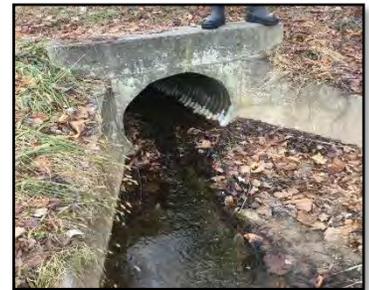
This project is located on Lynn Boulevard, south of the Humpton Road intersection at the stream crossing. The pipe is a 36-inch corrugated metal pipe conveying an Unnamed Tributary to Beaver Creek. The pipe is showing significant signs of scale rust formation along the bottom of the pipe, which is present along the entire bottom of the pipe. Additionally, the upstream conditions indicate that the pipe may be inadequately sized. It is recommended that the size of the pipe be evaluated and lined to extend the life of the pipe.

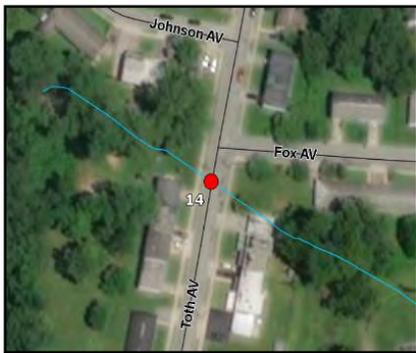
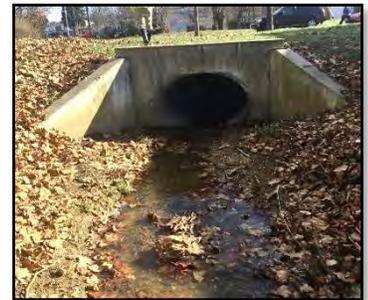
This project is located on Toth Avenue, south of the Fox Avenue intersection at the stream crossing. The structure is a corrugated metal arch approximately 42-inches in height by 66-inches in width conveying Valley Run. The pipe has significant scaling rust that is visible along the bottom of the pipe. In order to protect the structural integrity of the pipe, it is recommended that the pipe be lined, preventing further corrosion.

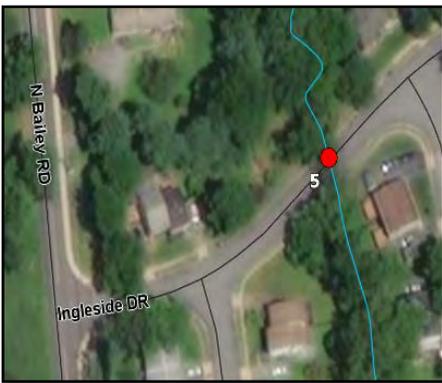
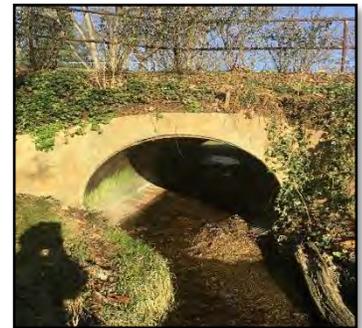
This project is located on Ingleside Drive, east of the North Bailey Road intersection at the stream crossing.

The corrugated metal arch structure is 62-inches in width by 87-inches in height conveying an Unnamed Tributary to Valley Run. There is significant scouring on the upstream side of the pipe with visible undermining occurring to a tree adjacent to the upstream headwall. Both upstream and downstream headwalls have cracks above the holes for the pipes. Significant corrosion is visible along the bottom of the pipe with pitting visible throughout the bottom of the pipe. It is recommended that the pipe gets lined to protect the structural integrity of the pipe. Repairs include lining the pipe and fixing the structure headwall cracks.
