**ROADWAY CONDITION EVALUATION**

**CALN TOWNSHIP  
CHESTER COUNTY, PENNSYLVANIA**

**File No. 23-07086**

**January 4, 2024**

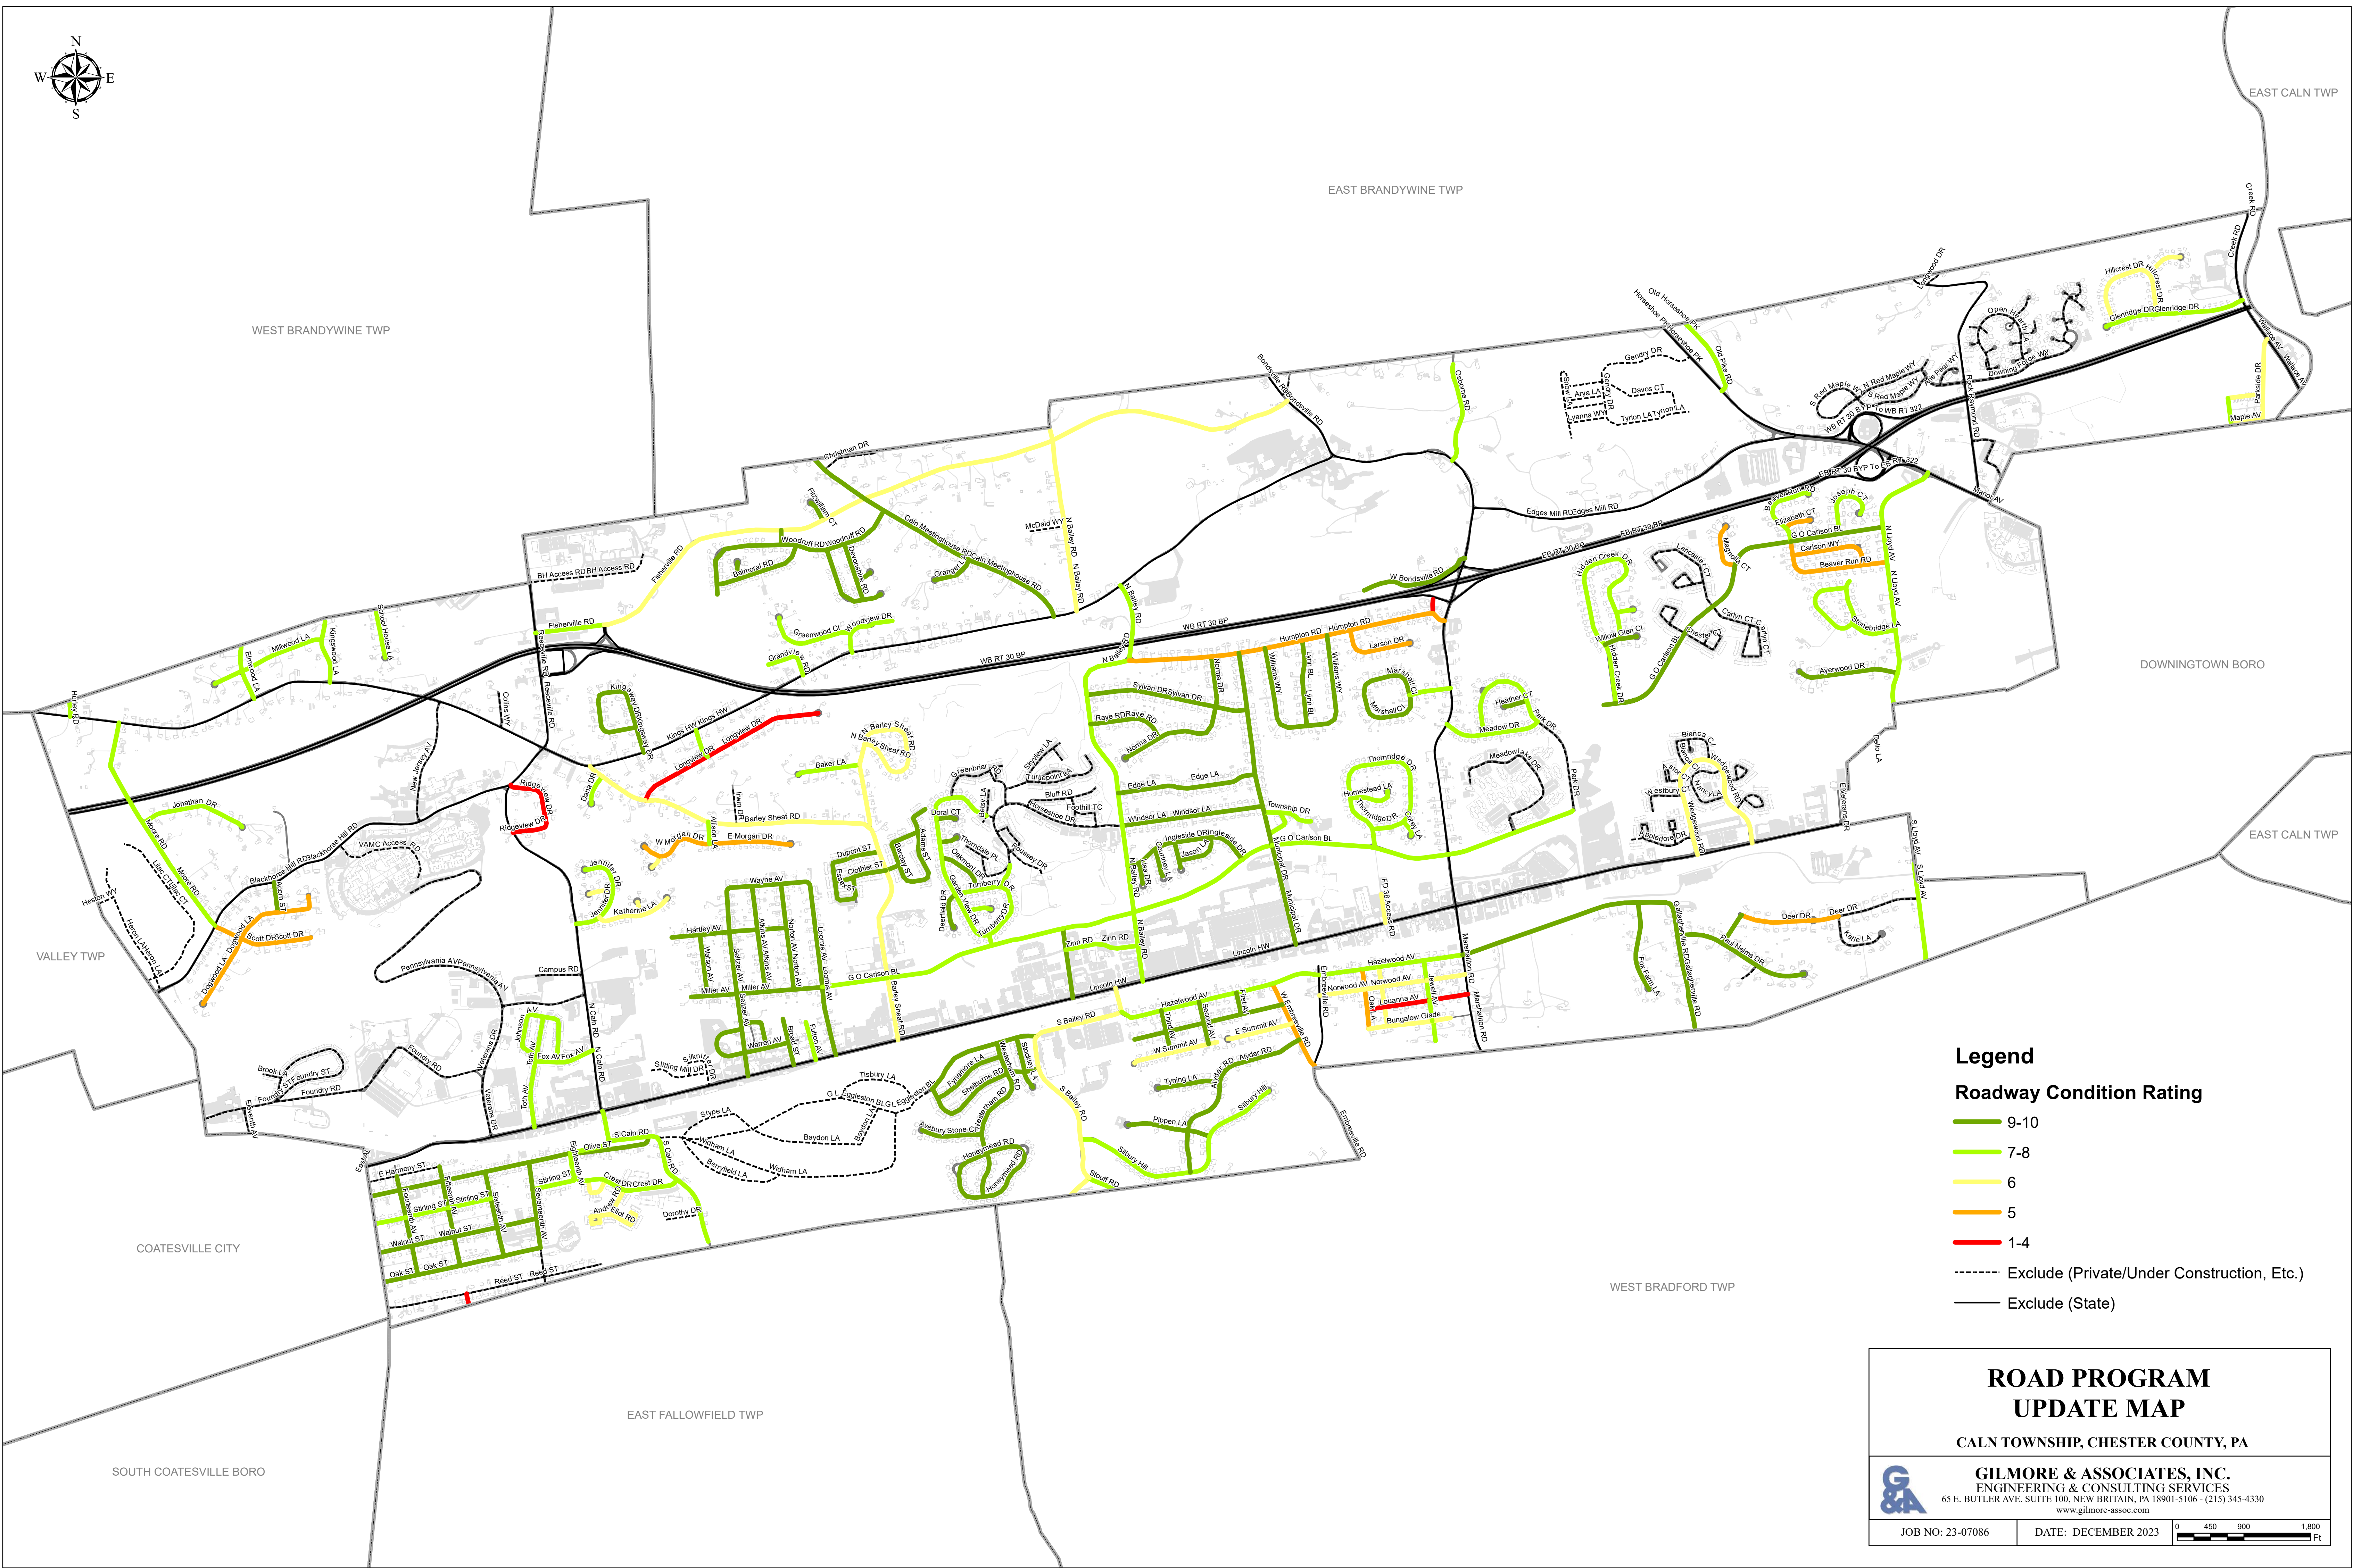
Based on the results of our assessment, the overall condition of the Township-owned road system is “good”, with over 75% of the roadways scoring a 7 or higher and no Township-owned streets scoring lower than a 4. The graph below titled *Graph 2: Caln Township Roadway Conditions*, summarizes the quantity of roads that earned each rating. The results suggest that the conditions of the Township’s roads are generally good; however, select roadways and roadway segments will require more significant repairs beyond a simple seal coating. Roadways that are only in need of general maintenance repairs such as seal coats or sealing localized distresses with minor patching represent approximately 75% to 90% of the Township roads currently in operation. Roadways in need of more intensive repairs, including pavement reconstruction and milling and overlaying represent approximately 10% to 25% of the Township roads.

The roadways that have scored a 5 or 6 are approaching a failure state, and should be prioritized for repairs. Five roads, including Fifteenth Street (south of Reed Street), Longview Drive, Louanna Avenue, North Humpton Road, and Ridge View Drive scored a rating of 4, which is considered a failure state (meaning that the roadways have deteriorated to the point where more significant and costly repairs are required). Repair of these roadways, which may require complete reconstruction of the pavement section, is recommended to be a top priority. Of the five roads receiving a failure score, North Humpton Road is in the worst condition. Repairs may include a partial or full replacement of the existing pavement structure as deemed necessary to bring the roadway back to a good or very good condition. For a tabulation of individual roadway ratings and distresses, please review the *Caln Township – Roadway Condition Summary* in the Appendix of this report.

The five roads that received a score of 4 or less— Fifteenth Street (south of Reed Street), Longview Drive, Louanna Avenue, North Humpton Road, and Ridge View Drive – are considered to be at their failure point. We recommend these roadways be repaired as soon as possible to avoid further deterioration and to improve the use of the roadways by Township residents. These roads will require pavement reconstruction and therefore will be the most expensive to repair. North Humpton Road is in the worst condition with multiple severe potholes.
