Caln Township Capital Improvements Plan

MAY 2019

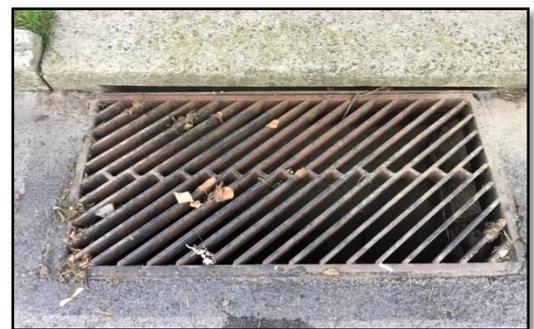
Figure 13 – Diagonal Slotted Grate

14. Due to the potential for bicycle tires to become trapped in slotted inlet style, causing an accident with potential injury for the rider, it is recommended that all slotted inlets within the right-of-way be converted to be bicycle safe.

While the bicycle safe grate is the preferred method, at a minimum the diagonal slotted grates should be replaced with slots running perpendicular to the lane of travel. This will minimize the potential hazard for bicyclists allowing them to travel over the structure with minimal risk.

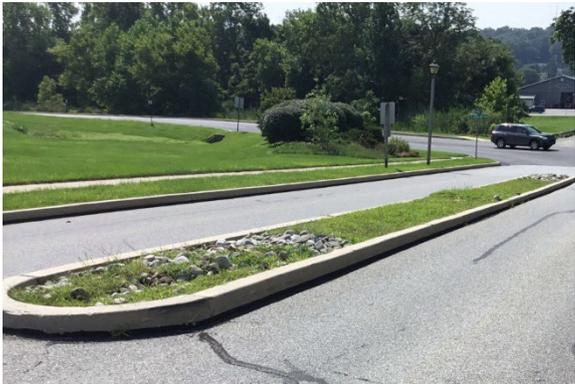
Thornridge Drive	Fair

It is recommended that the existing streetscapes that were rated Fair be upgraded with a vegetation diversity. When implementing streetscaping in new locations, major Township roadways should be considered. Placing streetscaping along highly-traveled, business roads will promote traffic-calming where it is most needed and boosts economic activity by encouraging people to shop in the area. Further recommendations include general maintenance of these streetscapes to ensure that they are functioning properly such as: weeding, vegetation trimming, trash and debris removal, infrastructure repairs.

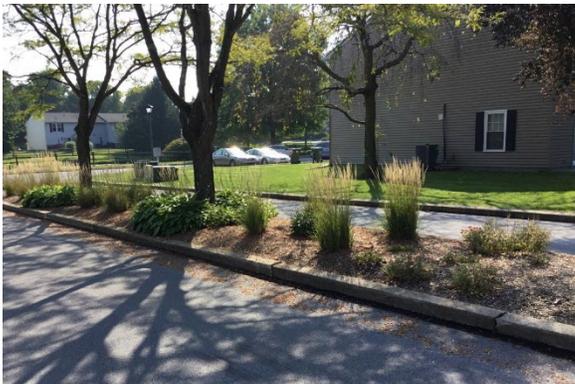
Clothier Street	Excellent

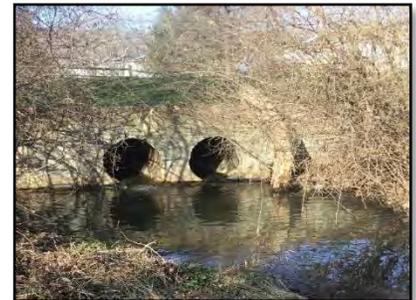
This project is located on Adams Street, within the Barley Sheaf Farms community, south of the pond at the stream crossing. The structure consists of two 36-inch corrugated metal pipes conveying an Unnamed Tributary to Valley Run. The downstream end, where the pipe outlets to an endwall was significantly scoured. The overall stability of the endwall should be monitored to ensure that no undermining does occur and that the structure is not at risk of falling over into the stream. Significant scaling rust is present throughout the bottom of both pipes. It is recommended that the pipes be lined in order to prevent further corrosion in the pipe and to protect its structural integrity.

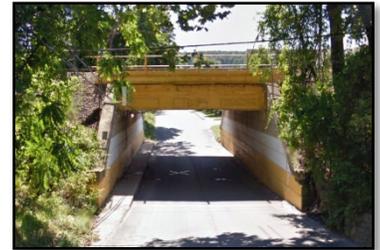
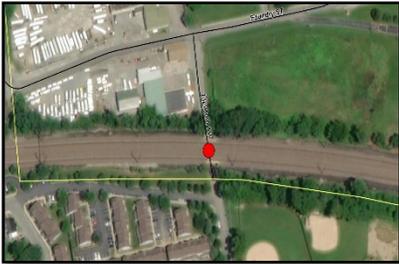
This project is for stormwater improvements to 11th Avenue underneath the Amtrak overpass. During significant rain events, the current system becomes overwhelmed by the volume of water directed at the system, causing the roadway to flood. This flooding makes travel difficult as residents must travel to a different underpass in order to safely get to the other side of the railroad tracks. Due to this safety hazard, it is recommended that the Township work to resolve these stormwater issues. A feasibility study should first be conducted in order to define a clear scope of work. At this time, a budget was not defined for this project due to scale and project complexity.

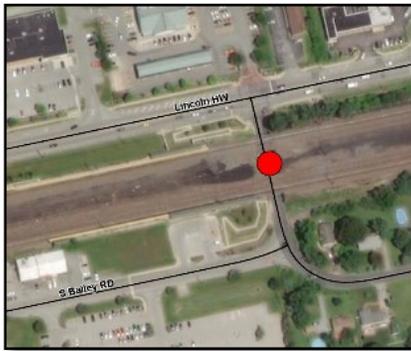
This project is for stormwater improvements to South Bailey Road underneath the Amtrak overpass. During this evaluation, the

existing infrastructure was unable to be assessed as most of the inlets in the area were filled with debris. The inlets that were able to be evaluated, prior to the entrance of the underpass showed pipes that are likely undersized for the volume of water that is going through them. Further investigation should be done to confirm this, however. During significant rain events, the current system becomes overwhelmed by the volume of water directed at the system, causing the roadway to flood and have to be closed. This flooding makes travel difficult as residents must travel to a different underpass in order to safely get to the other side of the railroad tracks. Due to this safety hazard, it is recommended that

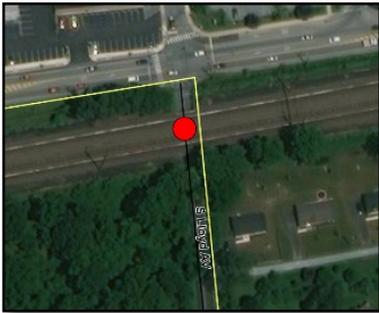
This project is for stormwater improvements to South Lloyd Avenue underneath the Amtrak overpass. During this evaluation, the existing infrastructure was unable to be assessed as most of the inlets in the area were filled with debris. The inlets that were able to be evaluated, prior to the entrance of the underpass showed pipes that are likely

undersized for the volume of water that is going through them. Further investigation should be done to confirm this, however. During significant rain events, the current system becomes overwhelmed by the volume of water directed at the system, causing the roadway to flood and have to be closed. This flooding makes travel difficult as residents must travel to a different underpass in order to safely get to the other side of the railroad tracks. Due to this safety hazard, improvements to stormwater infrastructure is proposed to address the flooding. A feasibility study should first be conducted in order to define a clear scope of work. At this time, a budget was not defined for this project due to scale and project complexity.

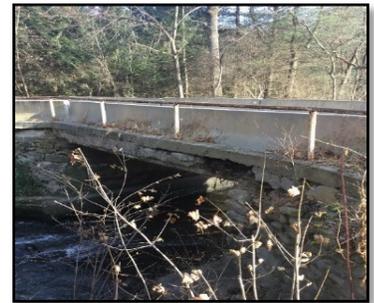
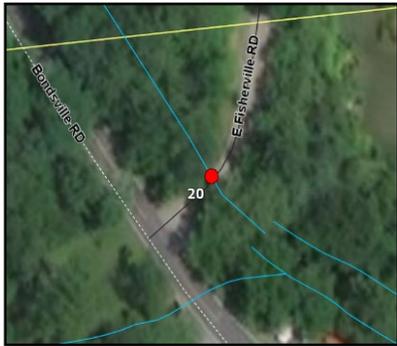
EAST FISHERVILLE ROAD BRIDGE REPLACEMENT

This project is located on East Fisherville Road, east of the Bondsville Road intersection at the stream crossing. The bridge conveys Beaver Creek and was constructed using stone masonry and concrete. The bridge is currently closed due to its condition. It is recommended that the structure gets demolished and replaced with a new structure. This is being recommended due to potential safety concerns with the permanent closure or removal of the structure.

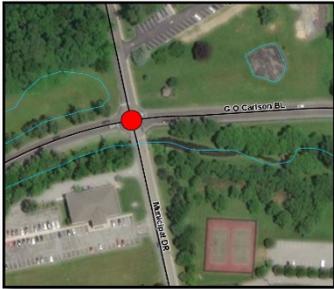
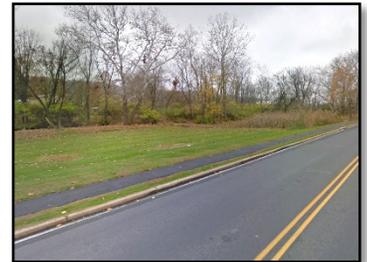
G.O. Carlson Boulevard’s trail is 2.11 miles. Currently, the path along G.O. Carlson Boulevard serves as the foundation for the development of trail alignment options within Caln Township. It is recommended that the existing path be used for the Chester Valley Trail

Extension (CVTE) along with upgrades that include widening the trail to 10-feet or more in order to support increased usage.

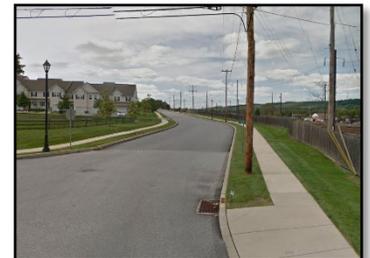
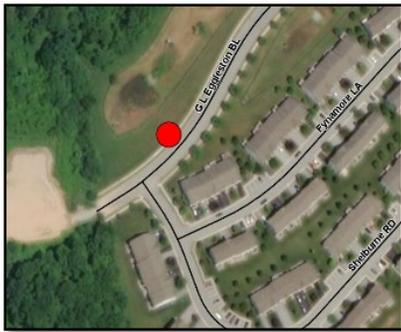
G.O. Carlson Boulevard’s trail is 0.34 miles. Currently, the path along G.L. Eggleston Boulevard serves as the foundation for the development of trail alignment options within Caln Township west of Bailey Road. It is recommended that the existing path be used for trail alignment as a scenic route. Due to the limited crossings of the Amtrak rail line, this extension should be evaluated in coordination with the alignment options in the City of Coatesville.
