# Caln Township Capital Improvements Plan

JUNE 27, 2019

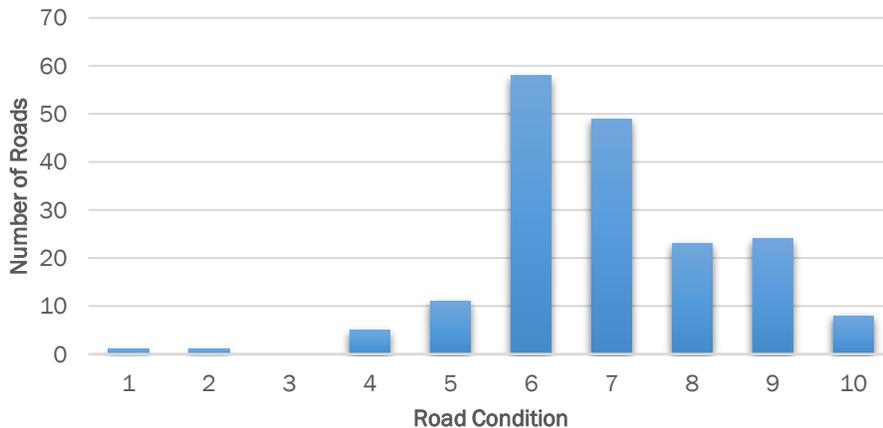
**Figure 5 - Caln Township Road Condition**

As shown in Figure 5, overall the condition of roads within the Township is poor to fair, with the majority of roadways having condition rating of 6 or 7. These results indicate that the condition of the Township's roads is not bad, however many of the roads require more extensive repairs than a simple seal coating. While many of the roads will require more extensive repairs, 58% of the roads are only in need of general maintenance activities such as sealing cracks or application of seal coats. While many of the roads are likely in need of more extensive repairs, such as mill and overlay, the 58 of the 69 roads in the poor category are ranked on the high end of this category, with a rating of 6. This still allows some time for the necessary repairs to these roads to be completed prior to the condition deteriorating to a point warranting even costlier repairs.

Seven roads, Ambrose Avenue, E. Fisherville Road, Fifteenth Avenue, Kingsway Drive, Oak Street, Seventeenth Avenue, and Sixteenth Avenue were found to have a condition rating of 4 or lower. This rating indicates that the conditions of these roads has deteriorated to a point where more extensive repairs are necessary. These repairs include a partial or complete replacement of the existing pavement structure are necessary in order to bring the pavement condition back to an excellent or good condition. A comprehensive listing of each road segment, the condition rating, distresses observed, and any issues noted with the roadway segment are provided in Appendix B. A map displaying the pavement condition of Township roads is provided in Appendix C.

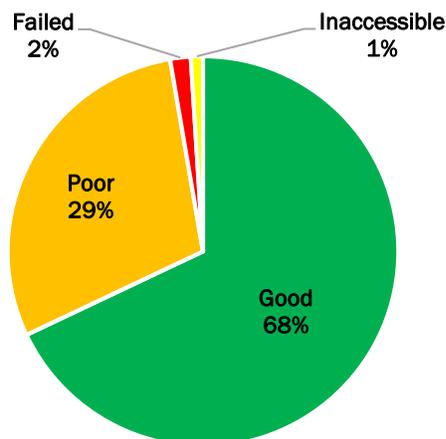
**Figure 10- Township Stormwater Conveyance Conditions**

Approximately 68% of the conveyances were rated in good condition as depicted in Figure 10. This result was not unexpected given that these conveyances are located within relatively new developments. These pipes were likely installed within the last 10-15 years, are closer to the start of their useful life and do not require repair. The remaining 403 CMPs are older and likely approaching the end of the design life as indicated by their poor condition rating. The

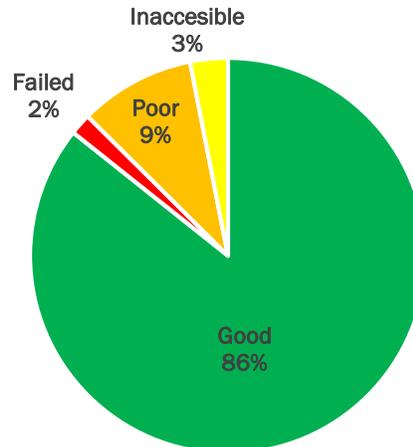
**Figure 11- Township Stormwater Structure Conditions**

Approximately 86% of the structure were rated in good condition as depicted in Figure 11. A total of 1,146 inlets and stormwater manholes were documented within the Township. These structures consisted of both newer pre-cast concrete structures and older brick structures. 36 structures were inaccessible due to manhole covers or inlet grates being sealed shut. The 21 structures rated as failed were primarily old brick inlets where collapsing brick was observed. These inlets should be completely replaced with new precast structures in order to ensure the stability of the soil and pavement around the structure remains intact and no subsidence occurs.

Structures observed to be in poor condition were a combination of both brick and concrete inlets with minimal loose bricks or mortar observed and water infiltrating through the bricks and concrete. These structures should have the loose brick and mortar repaired and any gaps where water is infiltrating sealed. Where applicable, lining of the inlets, should be implemented to potentially extend the life of the structures as recommended in the sections below. The results from this assessment will be incorporated into the final project recommendation ranking criteria.

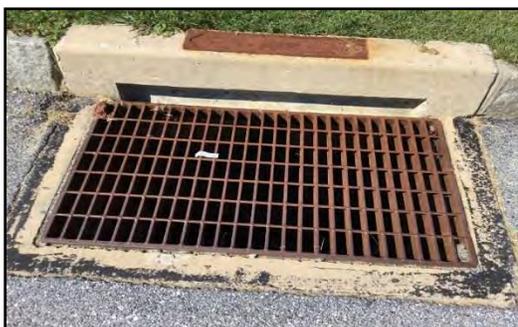
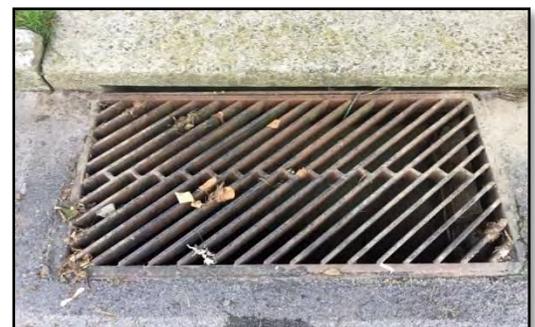
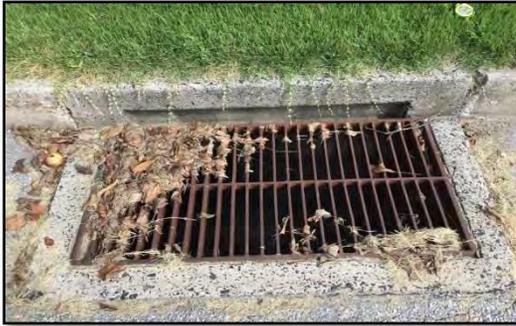
Figure 12 – Bicycle Safe Grate

shown in Figure 12, and slotted grates as shown in Figure 13 and 14. The slotted inlet grates shown in Figure 13 varied between the diagonal slotting shown and slotting that runs perpendicular to the path of travel, shown in Figure

14. Due to the potential for bicycle tires to become trapped in slotted inlet style, causing an accident with potential injury for the rider, it is recommended that all slotted inlets within the right-of-way be converted to be bicycle safe.

While the bicycle safe grate is the preferred method, at a minimum the diagonal slotted grates should be replaced with slots running perpendicular to the lane of travel. This will minimize the potential hazard for bicyclists allowing them to travel over the structure with minimal risk.

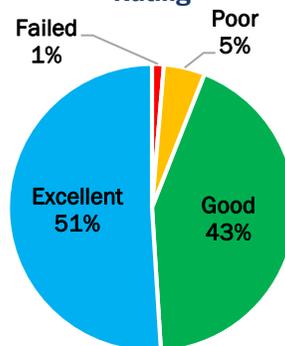
**Figure 15- Overall Existing Park Elements Condition Rating**

Overall, the majority of the elements within each of the parks were scored as Good or Excellent as depicted in Figure 15. There were some specific elements that need maintenance/repair and were assigned a score of Failed or Poor. These ratings will be reflected in the final project recommendation ranking criteria and will also align with the 2017 Caln Township Comprehensive Plan's Parks and Recreation recommendations to further improve existing recreational needs in Caln Municipal Park, Lloyd Park, Ruth A. Dawkins Memorial Park, and Caln Park West.

Based on the findings of the assessment, the overall recommendation for Caln Township's municipal parks and recreational facilities is to continue to perform general operations and maintenance activities to keep park amenities in good working order, safe, and to limit deferred maintenance that can prove more costly. Continuing to perform routine inspections, general maintenance and seasonal maintenance activities of the parks and the elements within them (i.e. benches, play equipment, trash cans) will ensure long-term within the facilities. These operation and maintenance recommendations are vital to the longevity of these facilities throughout the seasons.

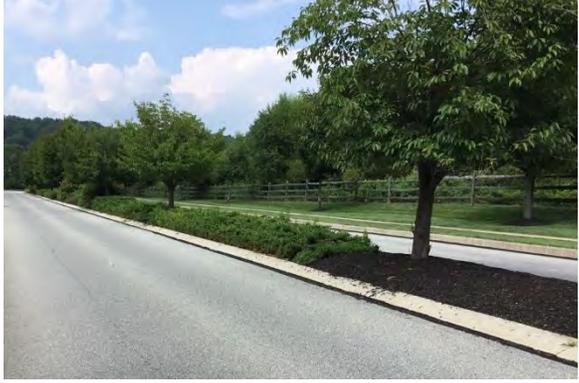
Road Location	Rating	Photo
Hidden Creek Drive	Excellent

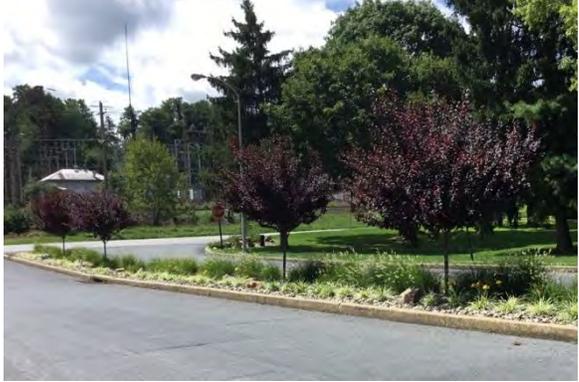
Wedgewood Road	Excellent

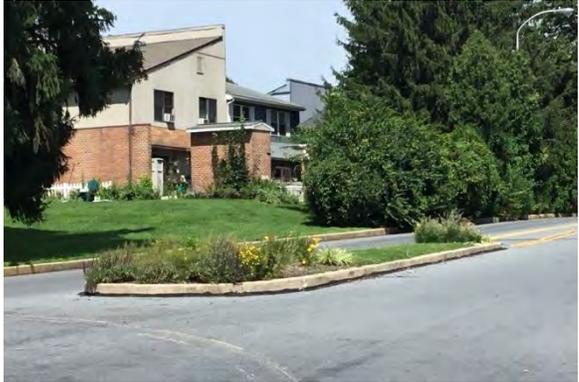
Wedgewood Road	Good

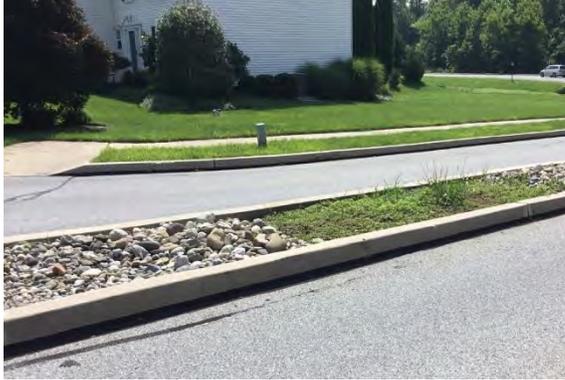
Road Location	Rating	Photo
Thornridge Drive	Fair

It is recommended that the existing streetscapes that were rated Fair be upgraded with a vegetation diversity. When implementing streetscaping in new locations, major Township roadways should be considered. Placing streetscaping along highly-traveled, business roads will promote traffic-calming where it is most needed and boosts economic activity by encouraging people to shop in the area. Further recommendations include general maintenance of these streetscapes to ensure that they are functioning properly such as: weeding, vegetation trimming, trash and debris removal, infrastructure repairs.

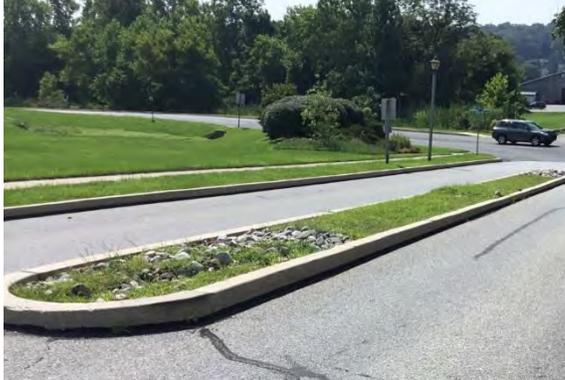
Thornridge Drive	Fair

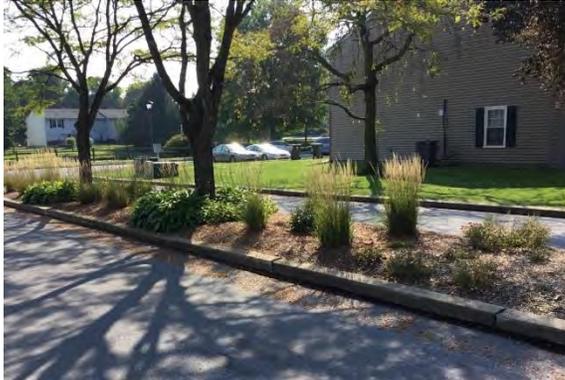
Clothier Street	Excellent

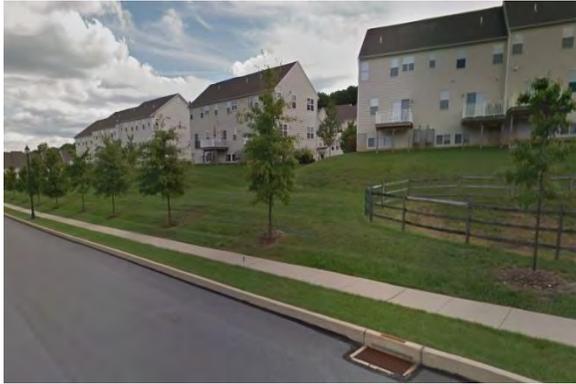
Road Location	Rating	Photo
G.L. Eggleston Boulevard	Good

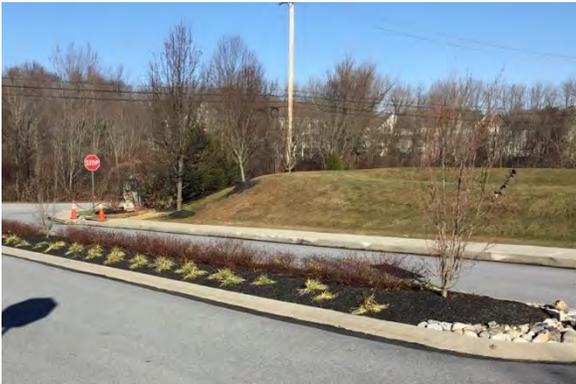
Kings Grant Boulevard	Good

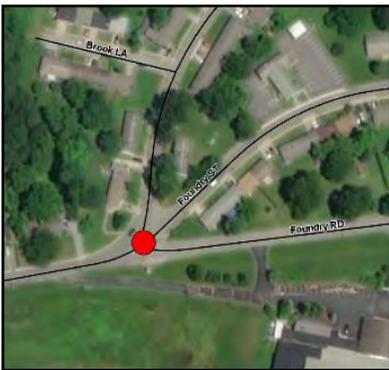
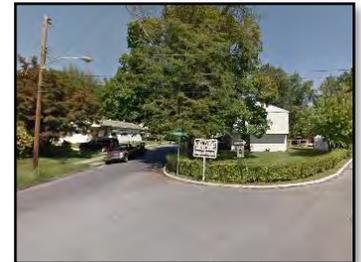
This project is located at the entrance of Carver Court on Foundry Street. Currently, there is a one-way sign at the entrance to the community however the flow direction of traffic is not clear. Vehicles are parked on either side of the road, restricting the width of the travel lane. Recommendations include further evaluation of the traffic patterns in this area and improvements to the signage and pavement markings.

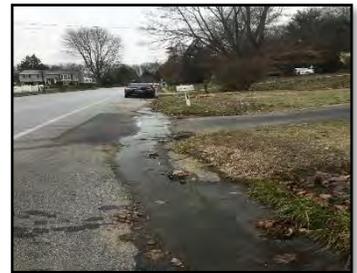
This project is located on Humpton Road between the Municipal Drive and Williams Way intersections on the northern side of the road. There is a rock/grass conveyance on private property that runs into the Township storm sewer system. The system conveys an ephemeral stream. During storm events, there is significant flooding, which has brought degradation to the stormwater system along Humpton Road and the private yards it runs through. It is recommended to restructure the system to withstand the flow from the ephemeral stream into the Township storm sewer system. These improvements would also help to reduce the icing potential along this portion of Humpton Road in the winter.

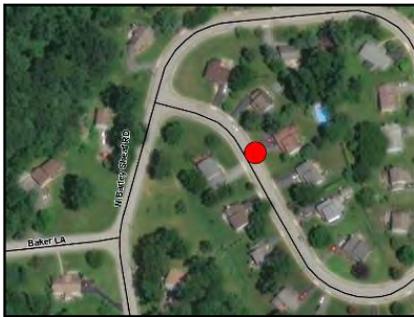
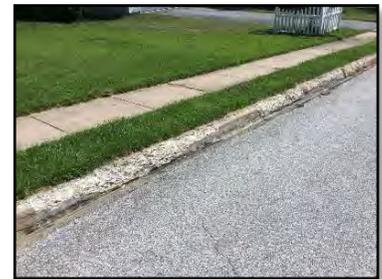
This project is located along North Barley Sheaf Road. The curbing along the road is eroding and deteriorating. This project should be completed in conjunction with additional road improvements to North Barley Sheaf Road in order to maximize construction resources.

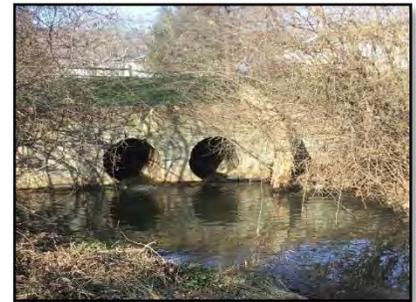
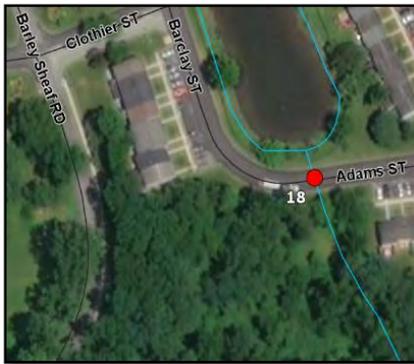
This project is located on Adams Street, within the Barley Sheaf Farms community, south of the pond at the stream crossing. The structure consists of two 36-inch corrugated metal pipes conveying an Unnamed Tributary to Valley Run. The downstream end, where the pipe outlets to an endwall was significantly scoured. The overall stability of the endwall should be monitored to ensure that no undermining does occur and that the structure is not at risk of falling over into the stream. Significant scaling rust is present throughout the bottom of both pipes. It is recommended that the pipes be lined in order to prevent further corrosion in the pipe and to protect its structural integrity.

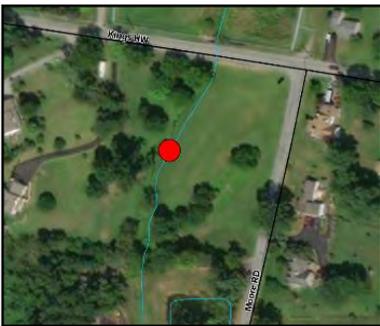
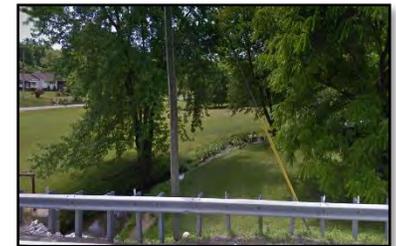
A minimum of 400 linear feet of stream restoration is being proposed along an unnamed (UNT) to West Branch Brandywine Creek on the property address 1208 Kings Highway near the intersection of Moore Road and Kings Highway. The reach of stream is eroded and actively incising. This project is proposed to address the Township's Municipal Separate Storm Sewer System (MS4) Pollutant Reduction Plan (PRP) sediment load requirements.

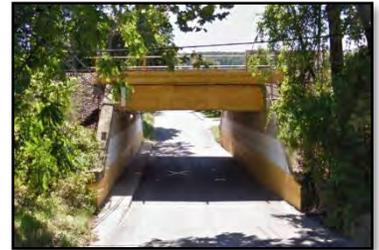
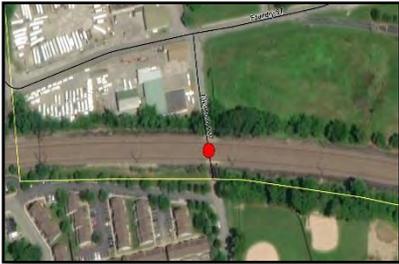
This project is for stormwater improvements to 11<sup>th</sup> Avenue underneath the Amtrak overpass. During significant rain events, the current system becomes overwhelmed by the volume of water directed at the system, causing the roadway to flood. This flooding makes travel difficult as residents must travel to a different underpass in order to safely get to the other side of the railroad tracks. Due to this safety hazard, it is recommended that the Township work to resolve these stormwater issues. A feasibility study should first be conducted in order to define a clear scope of work. At this time, a budget was not defined for this project due to scale and project complexity.

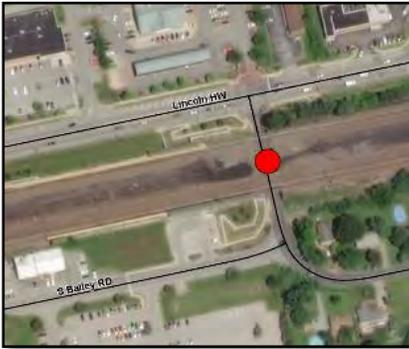
This project is for stormwater improvements to South Bailey Road underneath the Amtrak overpass. During this evaluation, the existing infrastructure was unable to be assessed as most of the inlets in the area were filled with debris. The inlets that were able to be evaluated, prior to the entrance of the underpass showed pipes that are likely undersized for the volume of water that is going through them. Further investigation should be done to confirm this, however. During significant rain events, the current system becomes overwhelmed by the volume of water directed at the system, causing the roadway to flood and have to be closed. This flooding makes travel difficult as residents must travel to a different underpass in order to safely get to the other side of the railroad tracks. Due to this safety hazard, it is recommended that the Township work to resolve these stormwater issues. A feasibility study should first be conducted in order to define a clear scope of work. At this time, a budget was not defined for this project due to scale and project complexity.

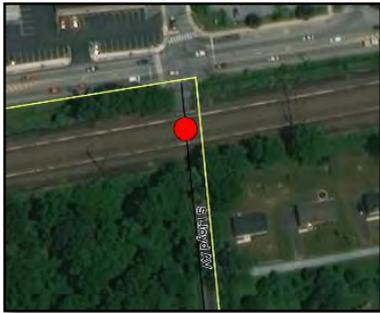
This project is for stormwater improvements to South Lloyd Avenue underneath the Amtrak overpass. During this evaluation, the existing infrastructure was unable to be assessed as most of the inlets in the area were filled with debris. The inlets that were able to be evaluated, prior to the entrance of the underpass showed pipes that are likely

undersized for the volume of water that is going through them. Further investigation should be done to confirm this, however. During significant rain events, the current system becomes overwhelmed by the volume of water directed at the system, causing the roadway to flood and have to be closed. This flooding makes travel difficult as residents must travel to a different underpass in order to safely get to the other side of the railroad tracks. Due to this safety hazard, improvements to stormwater infrastructure is proposed to address the flooding. A feasibility study should first be conducted in order to define a clear scope of work. At this time, a budget was not defined for this project due to scale and project complexity.

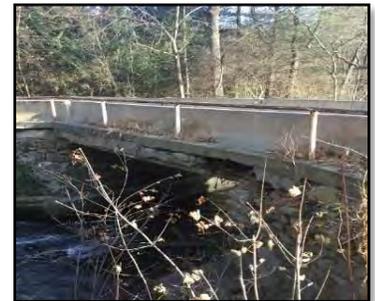
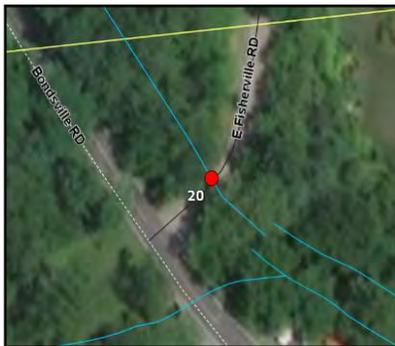
## ***EAST FISHERVILLE ROAD BRIDGE REPLACEMENT***

This project is located on East Fisherville Road, east of the Bondsville Road intersection at the stream crossing. The bridge conveys Beaver Creek and was constructed using stone masonry and concrete. The bridge is currently closed due to its condition. It is recommended that the structure gets demolished and replaced with a new structure. This is being recommended due to potential safety concerns with the permanent closure or removal of the structure.

This project has been identified as a large-scale project that will require outside funding. A feasibility study should be conducted to assess alternatives including consideration of closing the bridge.
